Successful Operation of SRU with Condenser(s) Bypassed

2022 Brimstone Sulfur Symposium - Vail

Lost Cabin Gas Plant

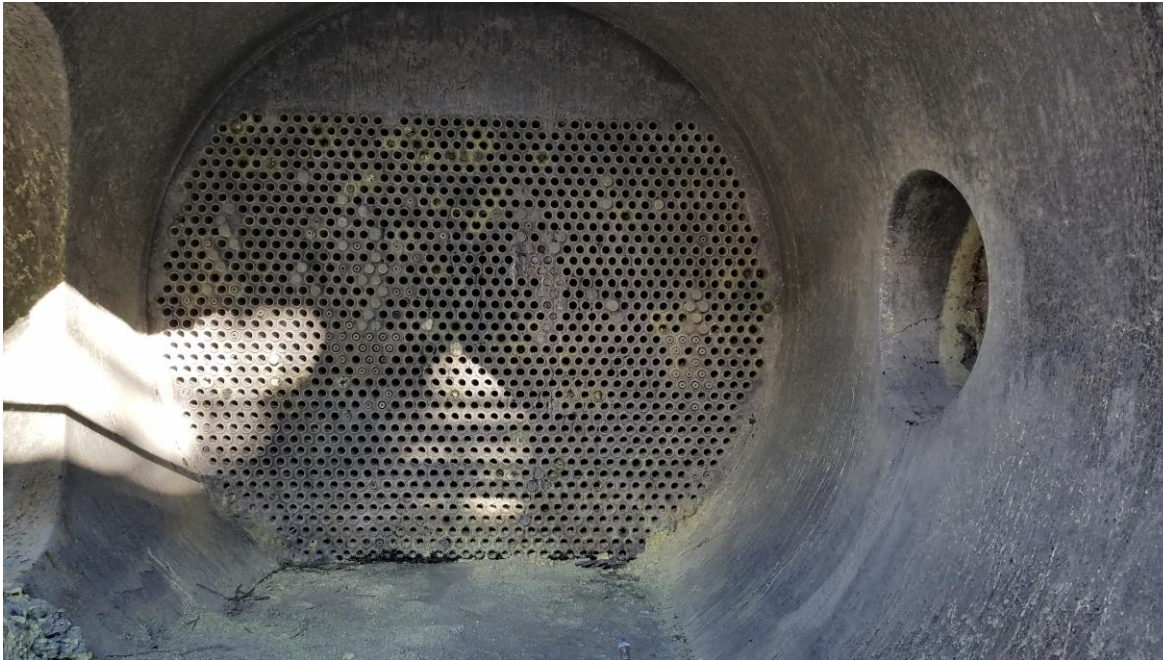
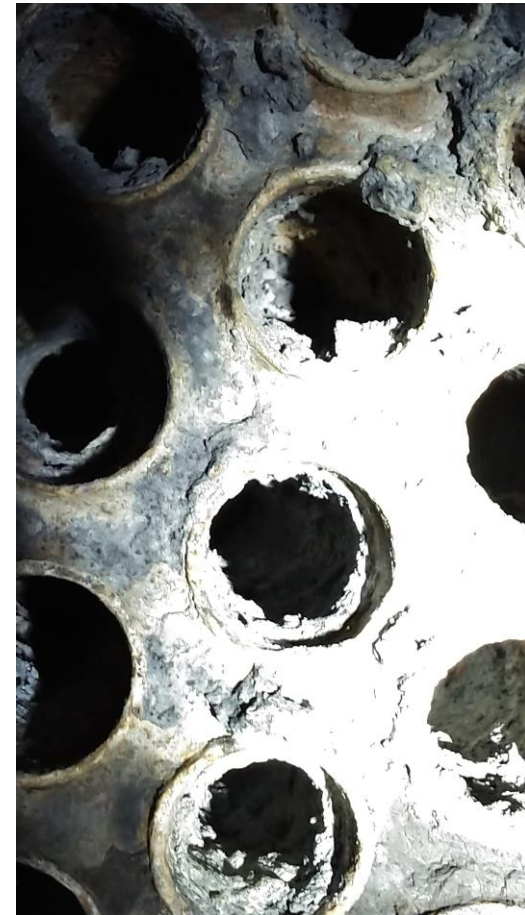
Initial Condenser Leak

- Fire occurred in the Train 3 Selexol unit in Dec. 2018
- 2 year rebuild; unit was restarted in Jan. 2021
- During restart activities, significant tube leaks discovered in the #3 condenser
 - Required plugging of 215/1600 tubes

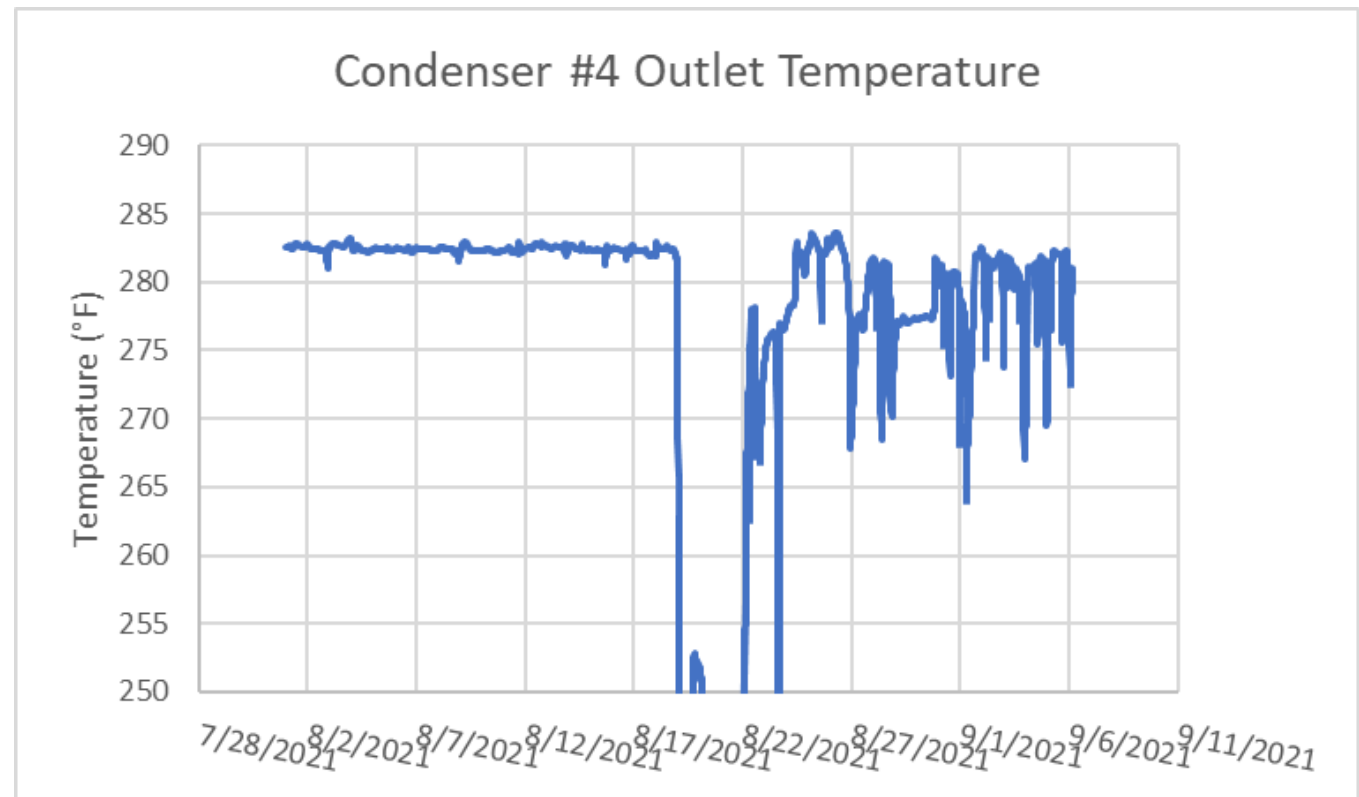
2nd Condenser Leak

- Unit was online from Feb. 2021-Aug. 2021
- Power outage in August caused the unit to be down for several days
- After coming back online, issues with the #4 above ground sulfur seal not flowing
- Also observed periodic drops in the vapor outlet temperature of #4 condenser
- Indicated potential tube leak in the condenser

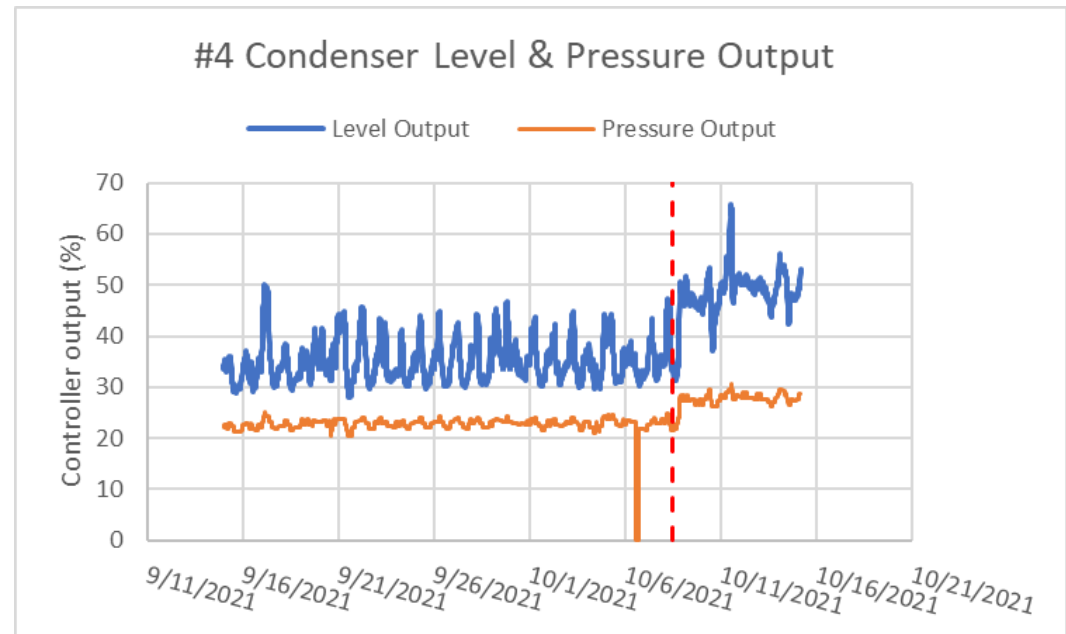
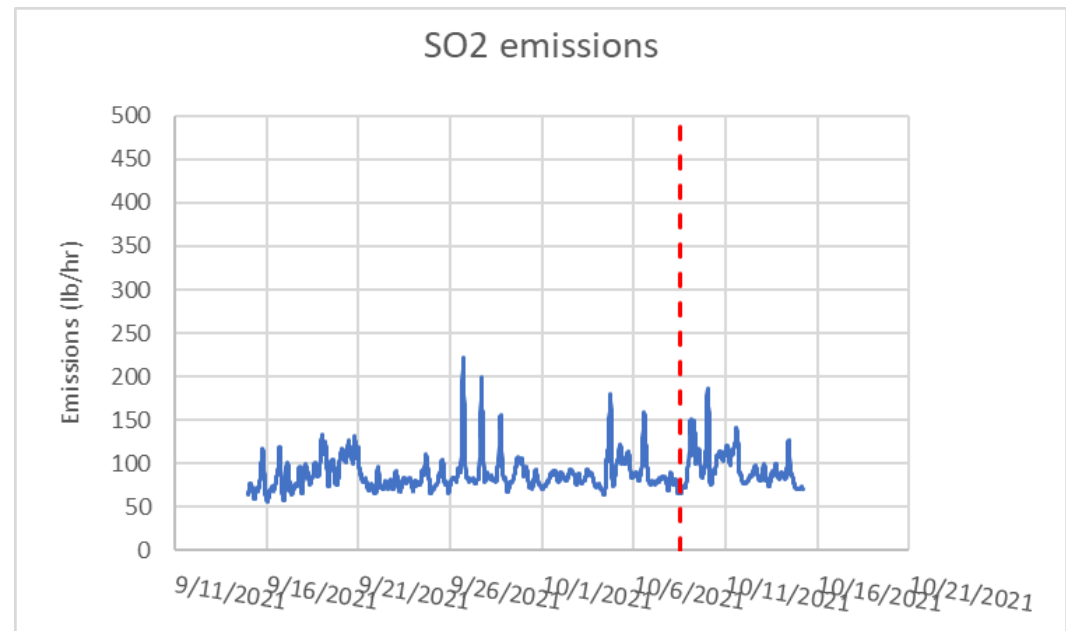
Operating Data with #3 Condenser Bypassed

- Level and steam control for #4 condenser also indicated load shifted
- No significant impact to SCOT. Emissions were stable
- Slight increase to normalized pressure
- At maximum well delivery, only needed to operate 75-80% design capacity

-- #3 condenser bypassed

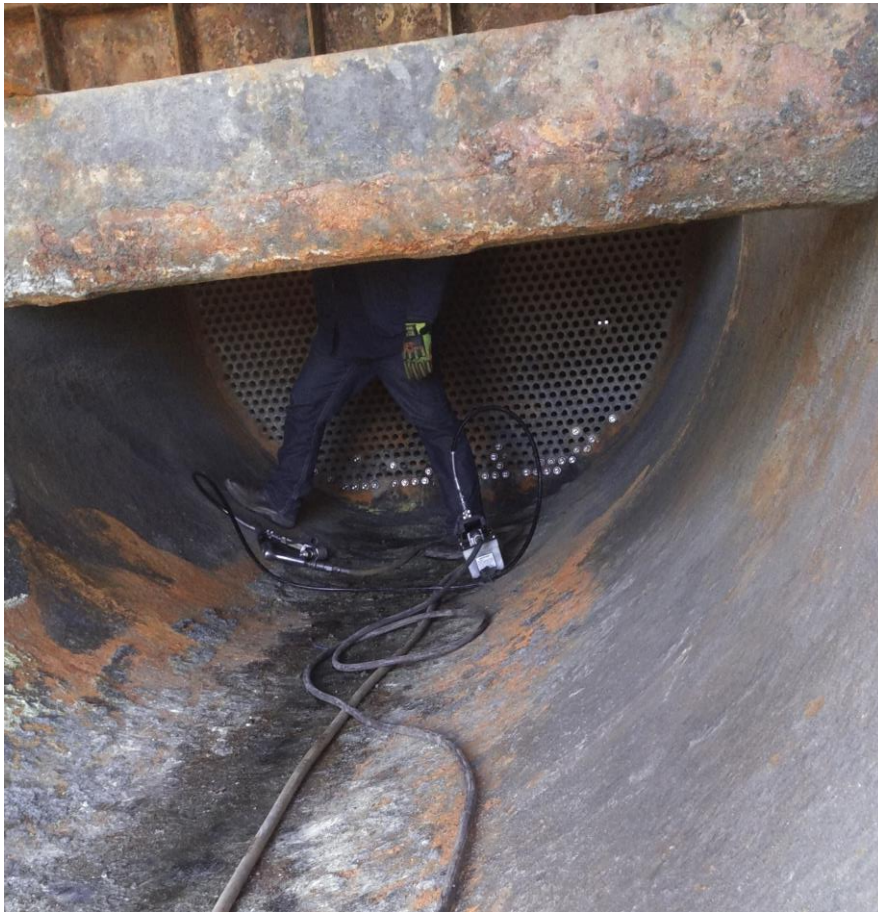
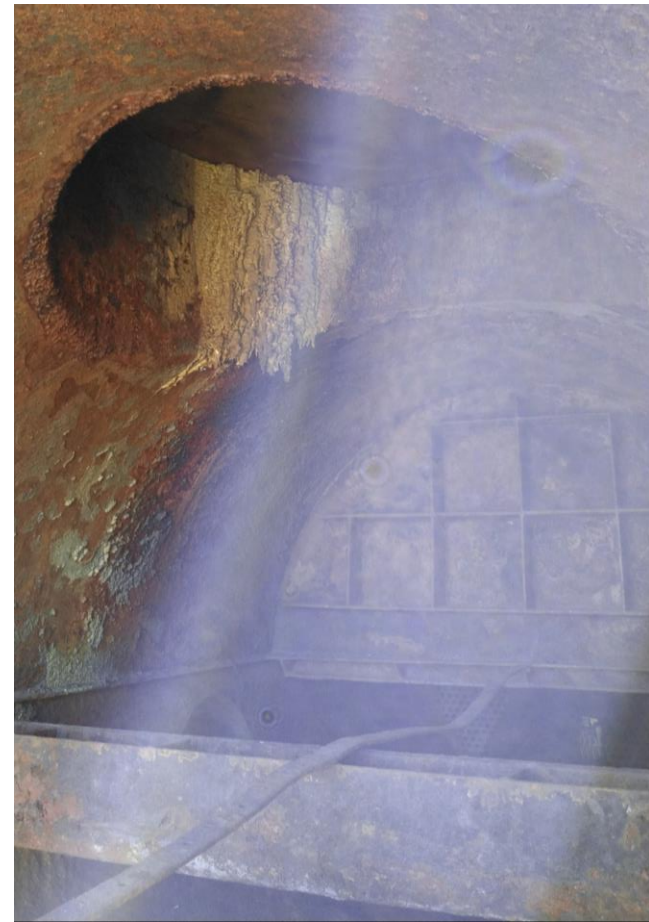
Turnaround Findings: #4 Condenser

- #4 condenser had 36 leaking tubes in bottom rows
 - Decided to plug entire bottom 6 rows
- Sulfur deposition observed on outlet nozzle

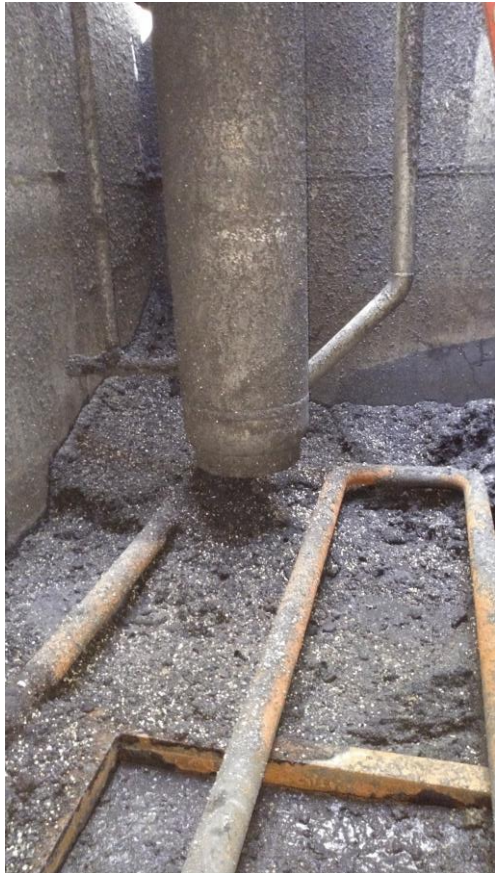
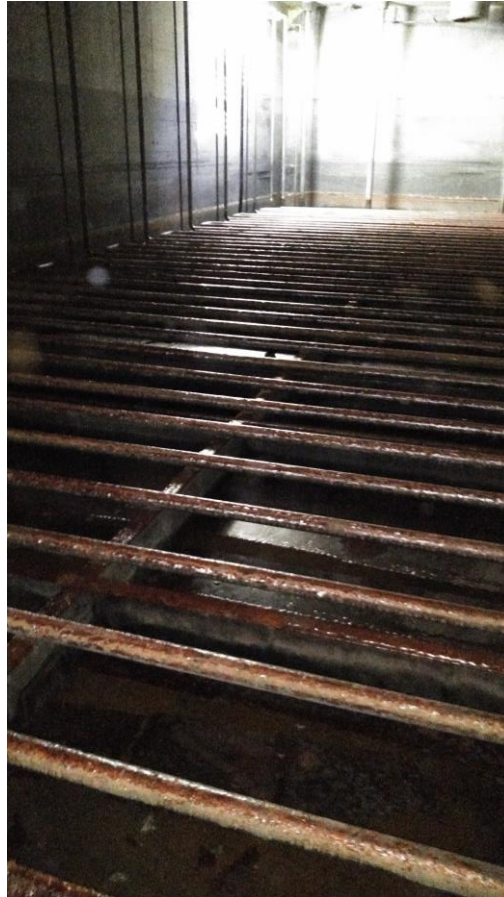
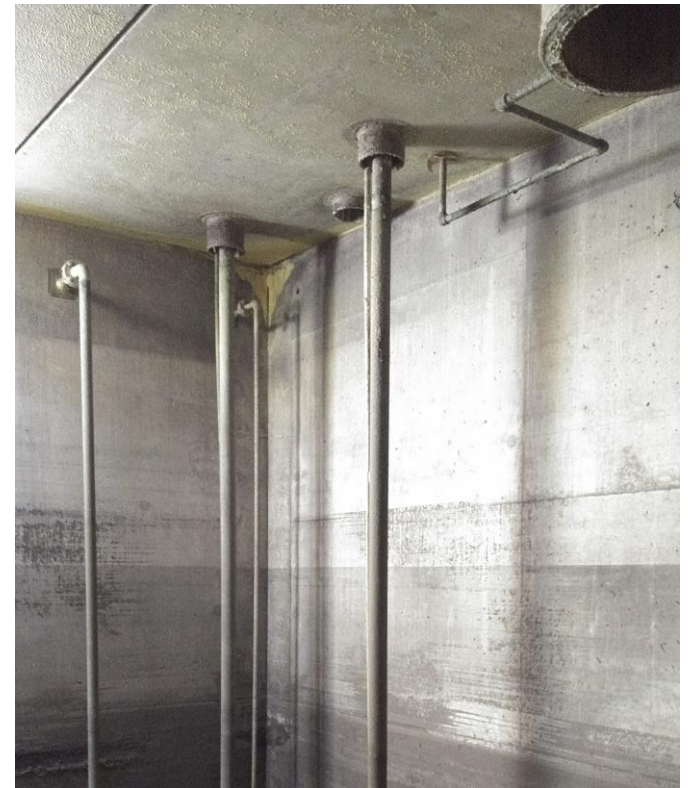
Turnaround Findings: Sulfur Pit

- Issues associated with inspecting sulfur pit
 - Hadn't been drained in 20 years. FeS smoldering- SO₂ off gas
 - Briefly put water in pit to allow for entry
- Findings
 - Sludge near inlet
 - Otherwise, no issues with steam coils or concrete
