# **Improving Thermal Reactor Safety With Refractory Enhancements**

Rick Johnson – BP

Jeff Proctor – Thorpe Specialty Services Corp

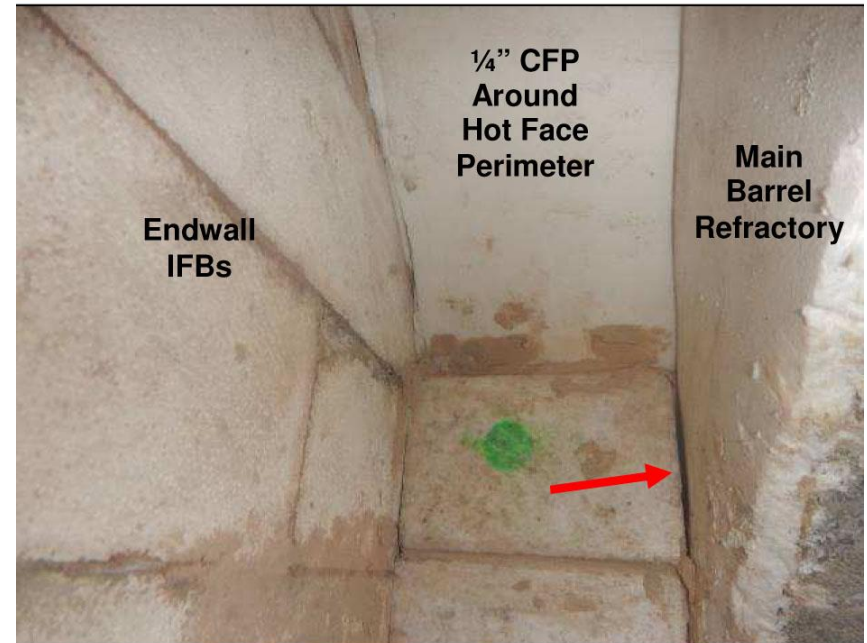
- “It was recommended that a ¼” thick ceramic fiber paper (CFP) layer was installed between the steel shell and the hot face bricks along the endwall perimeter **where no insulation back-up was present** and a ½” thick CFP was installed **between the hot face endwall refractory and the main barrel brick.**”

Gaps (red arrow) in installation due to deviations in the existing main barrel refractory.

**These are engineering decisions being made in the field by the maintenance contractor &/or the refractory inspector**

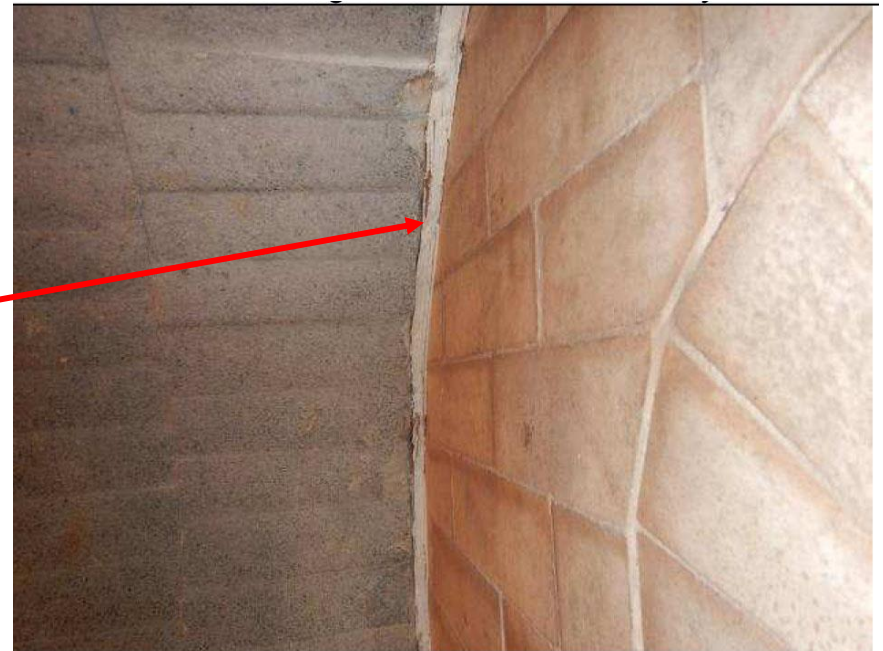
- “Due to movement in both the removed endwall bricks and the remaining main barrel bricks many areas required more than ½” of CFP. **Approximately 1”- 1½” of CFP was required to be installed between the endwall hot face refractory and the main barrel refractory to allow for a tight fit. The final CFP expansion joint was sealed with mortar** after approval and sign-off of the installation.”

CFB joint between the endwall and main barrel refractory measuring up to 1.5”.

**These are engineering decisions being made in the field by the maintenance contractor &/or the refractory inspector**

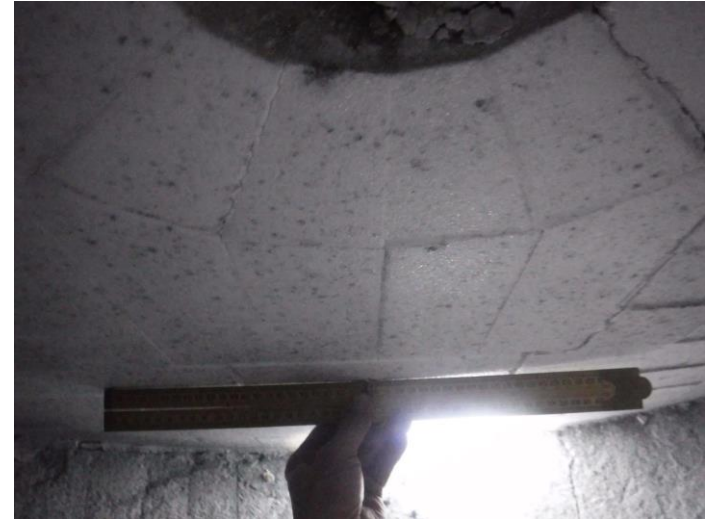
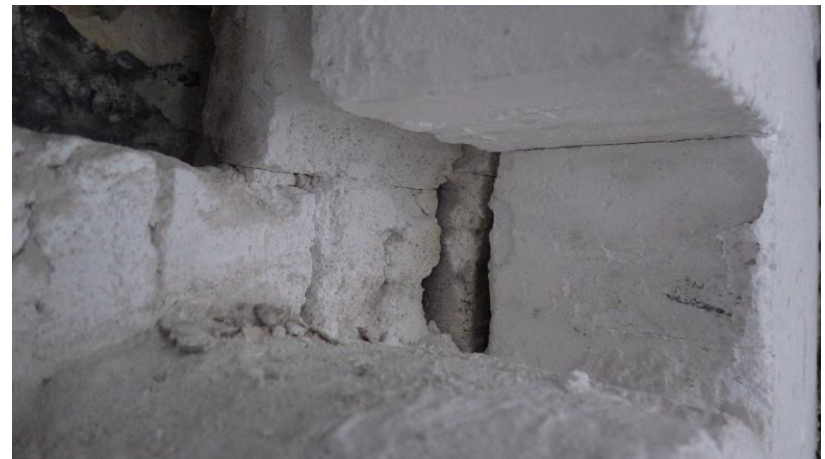
- ~1" gap between IFBs & steel
- Upon demo gap found to extend to outer rim

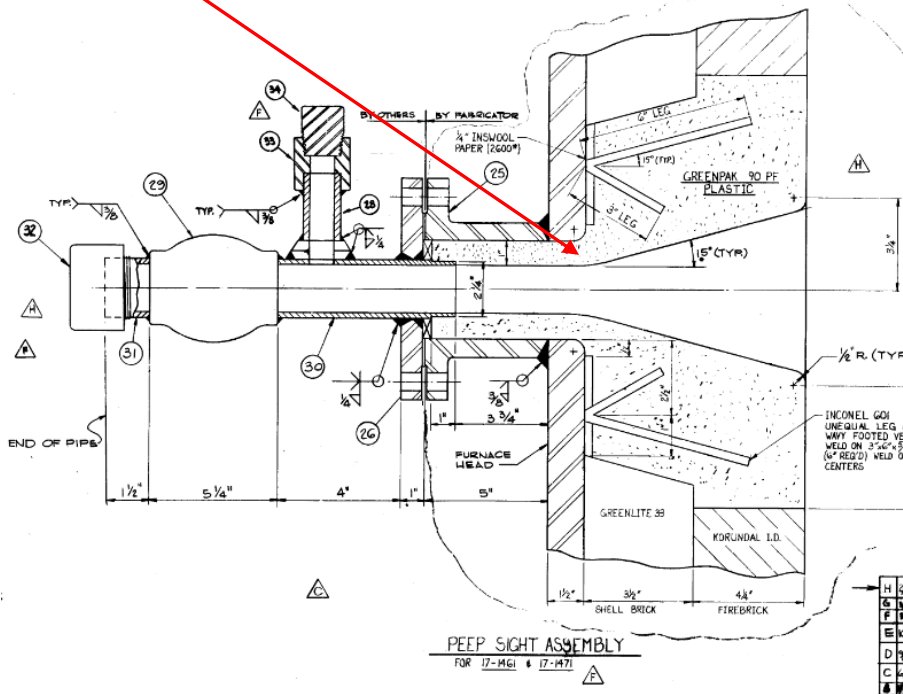
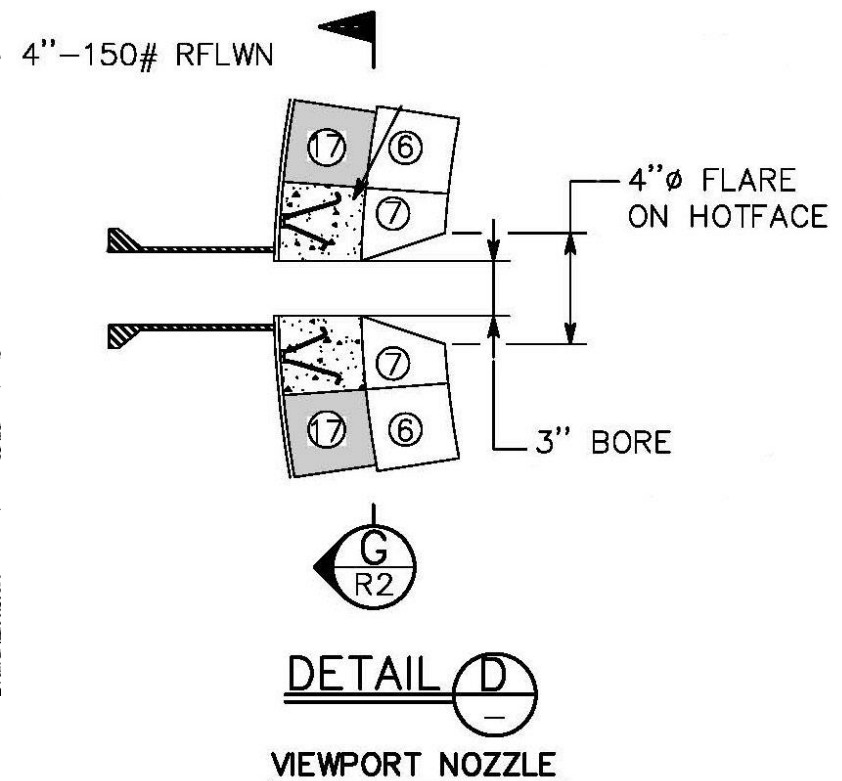
- No insulation material, all dense hotface material
- 1" refractory at shell

- 4-1/2" Insulation over shell, then 4-1/2" HF brick

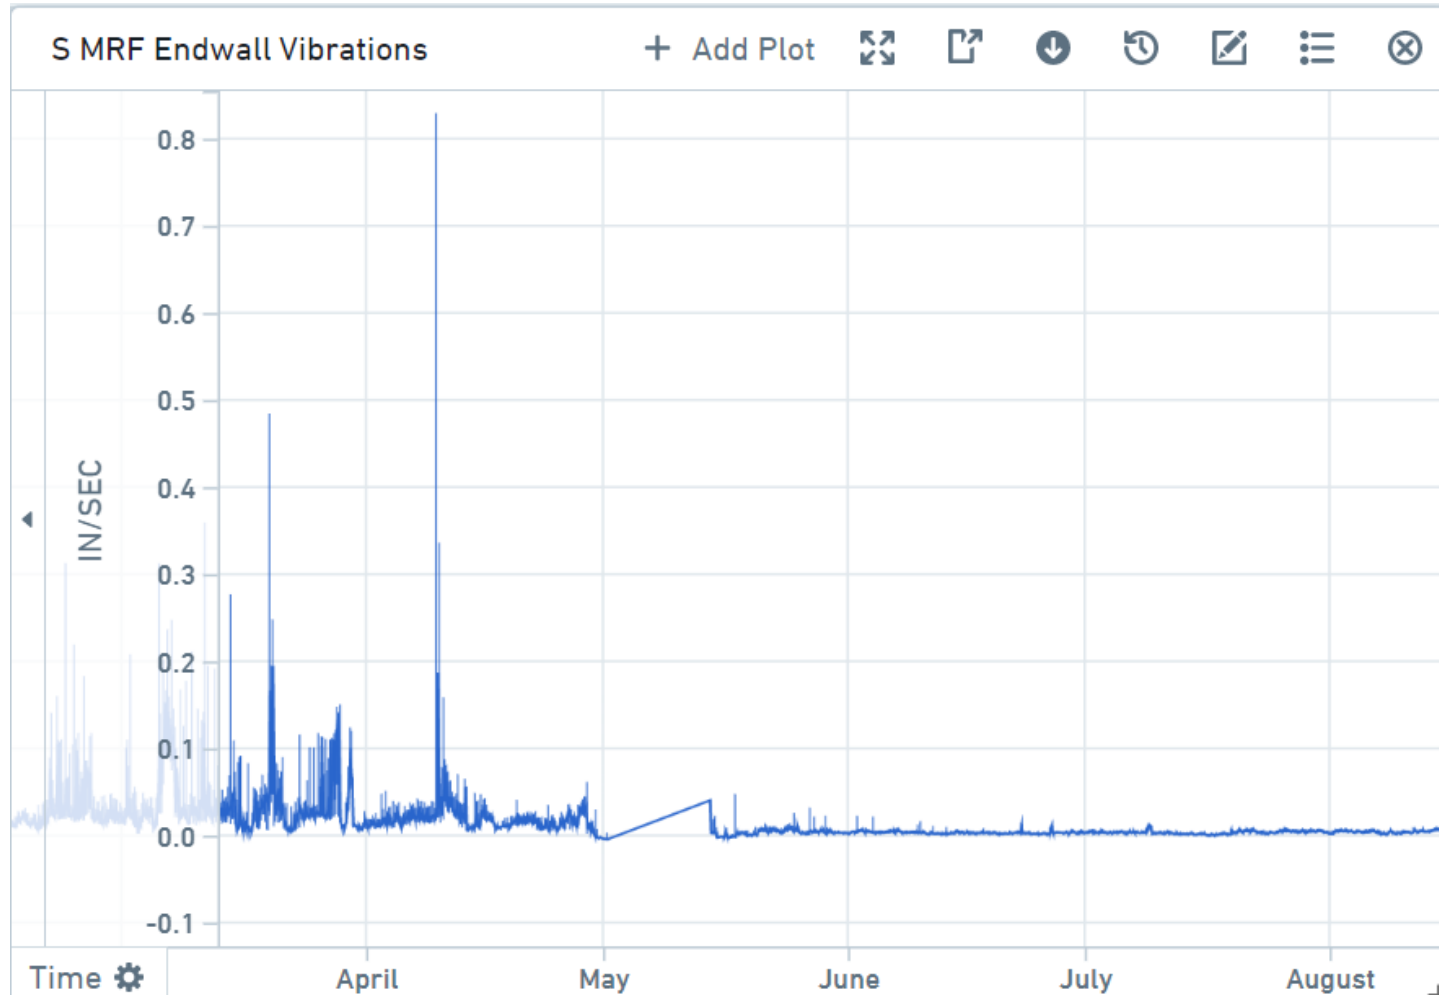
4 months of operation - no noticeable issues
