## Startup Foaming Issues on a New MDEA Tail Gas Unit

2021 Brimstone Sulfur Symposium

*S. Copper, K. Thomas, B. Viceria, S.  
Goff, J. Contreras, L. Nyadong, J.  
Stavros – Phillips 66*

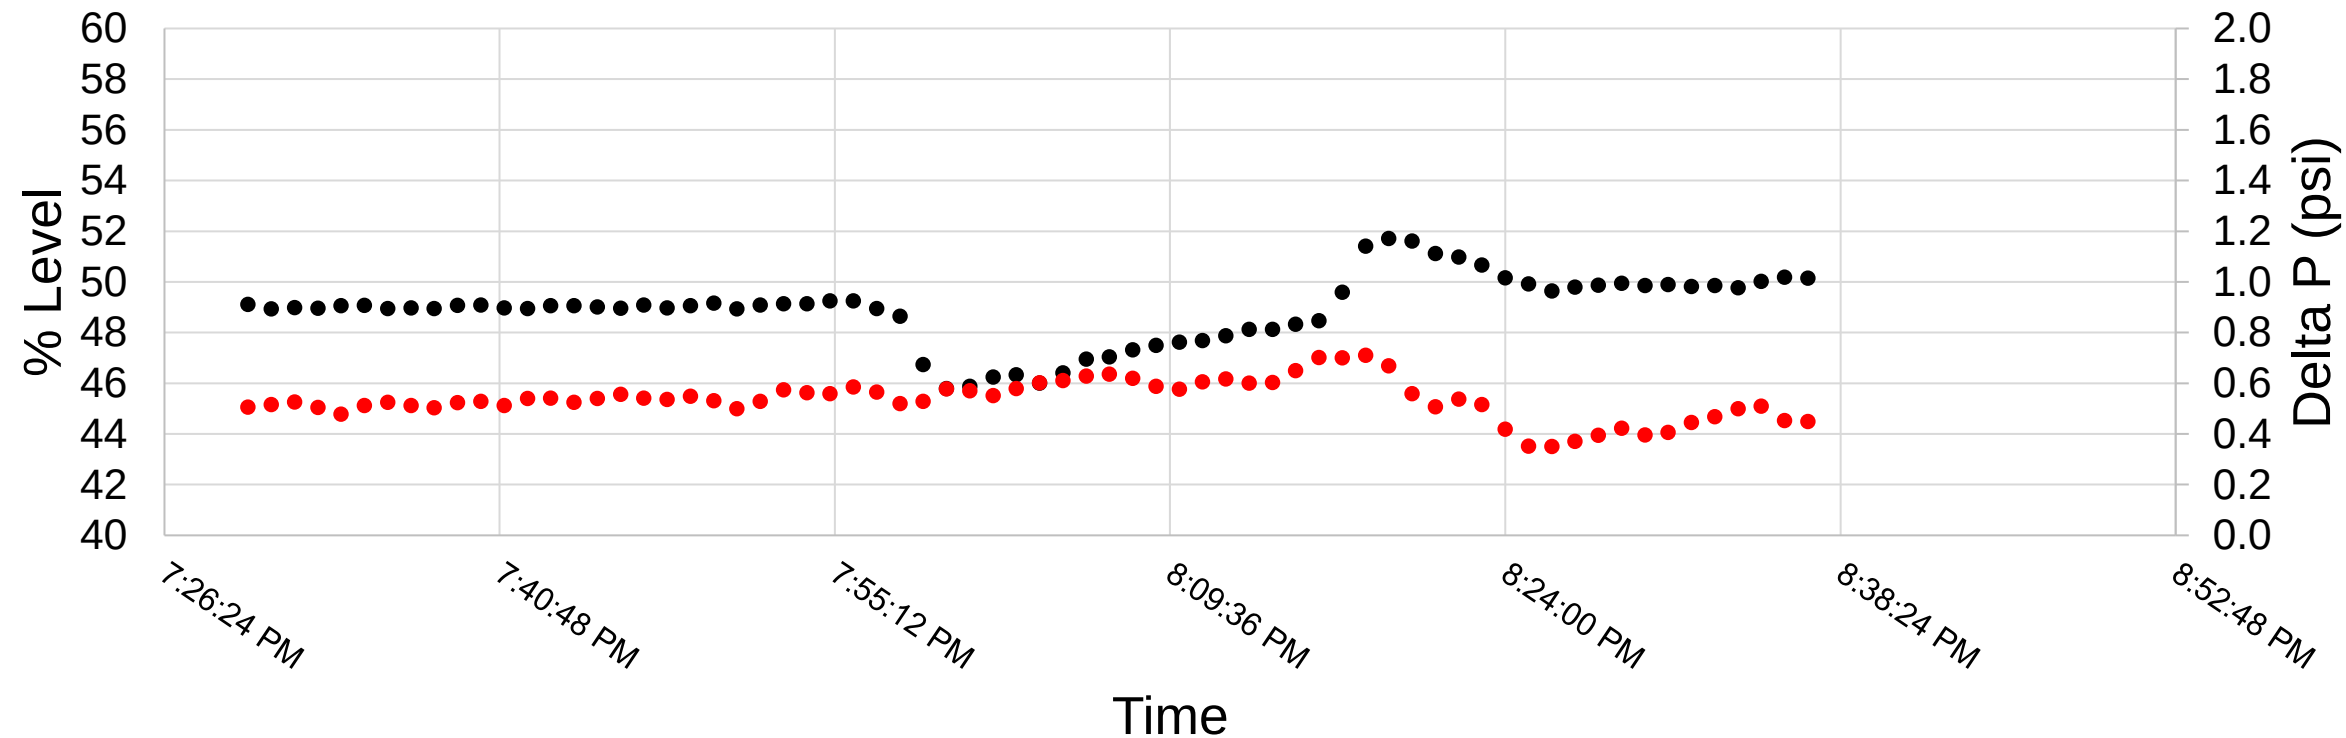
Figure 3: TGT Absorber Performance

- Absorber Btms Level
- Absorber Delta P

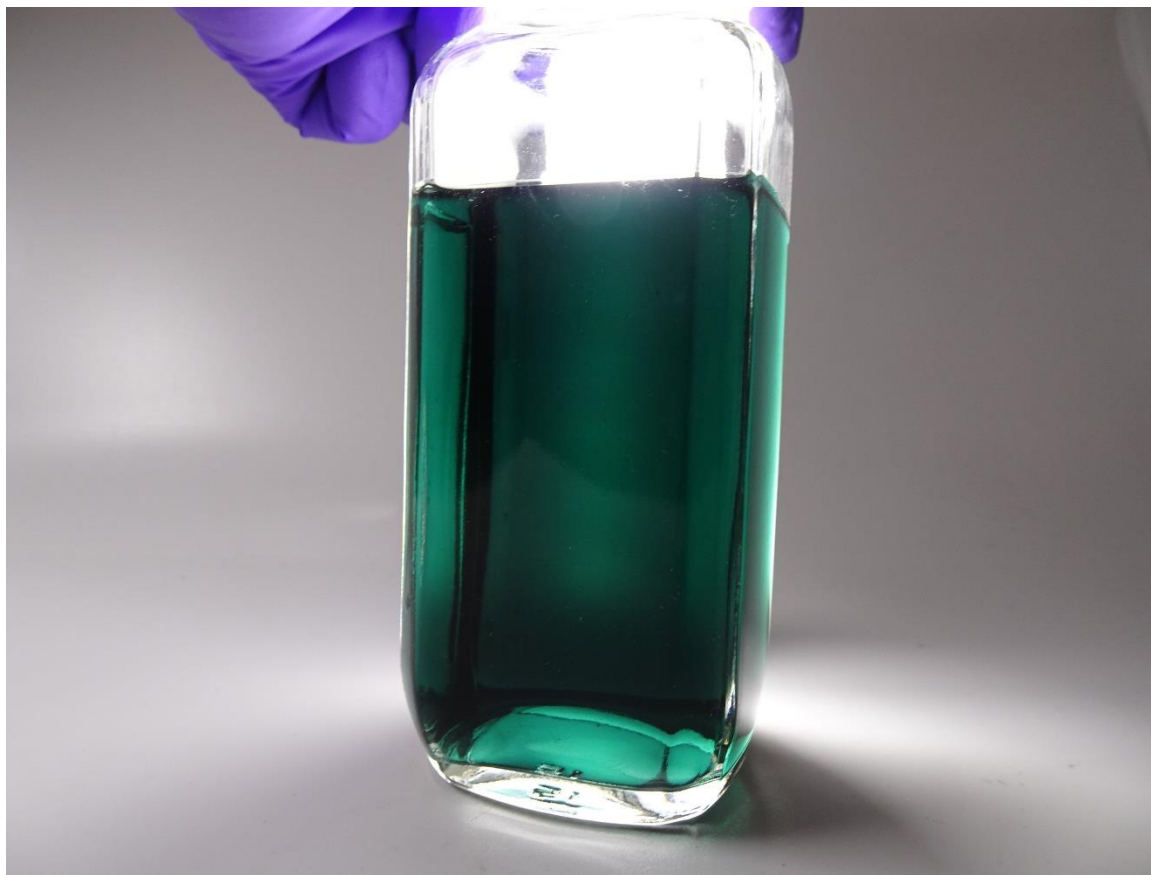
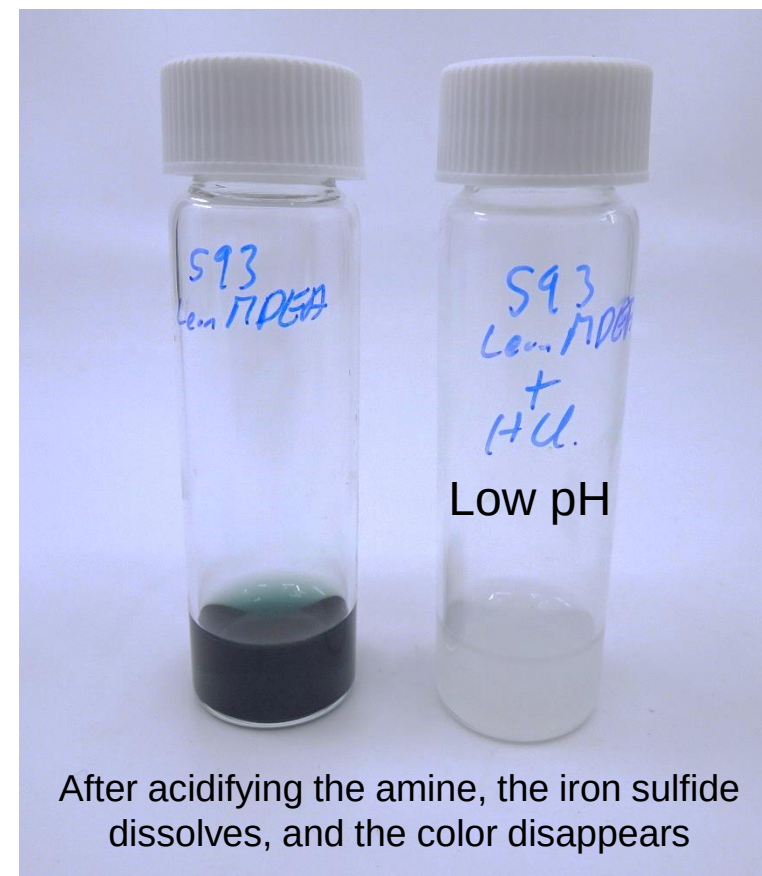
- The Emerald greenish color is known to be from the presence of extremely small colloidal iron sulfide particles in solution.
- Acidification of the amines with hydrochloric acid dissolves the iron sulfide particles making the color disappear.

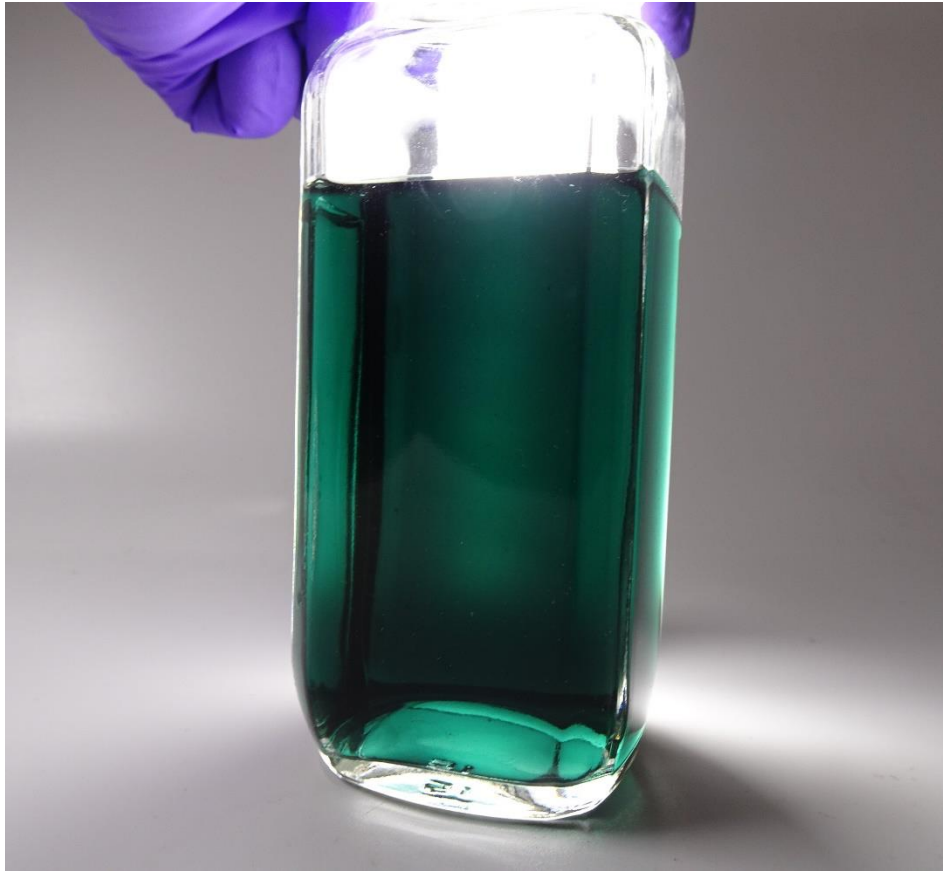
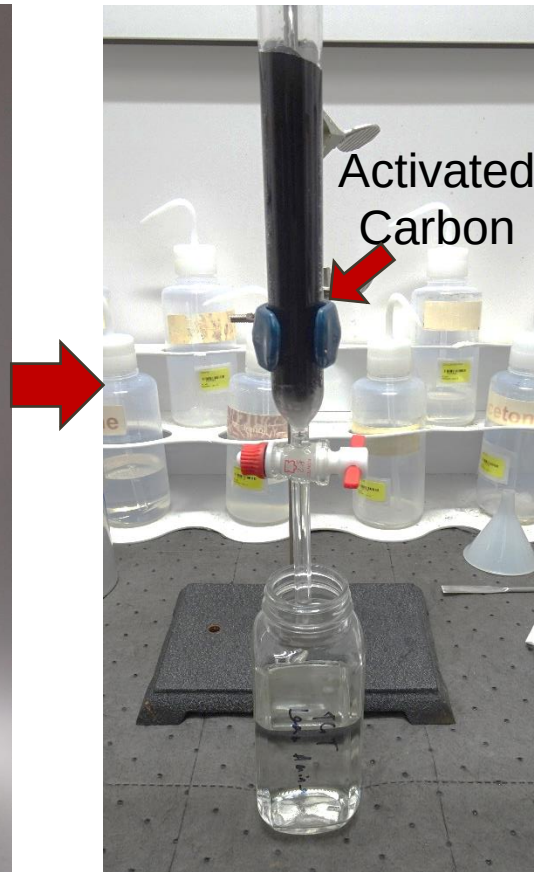
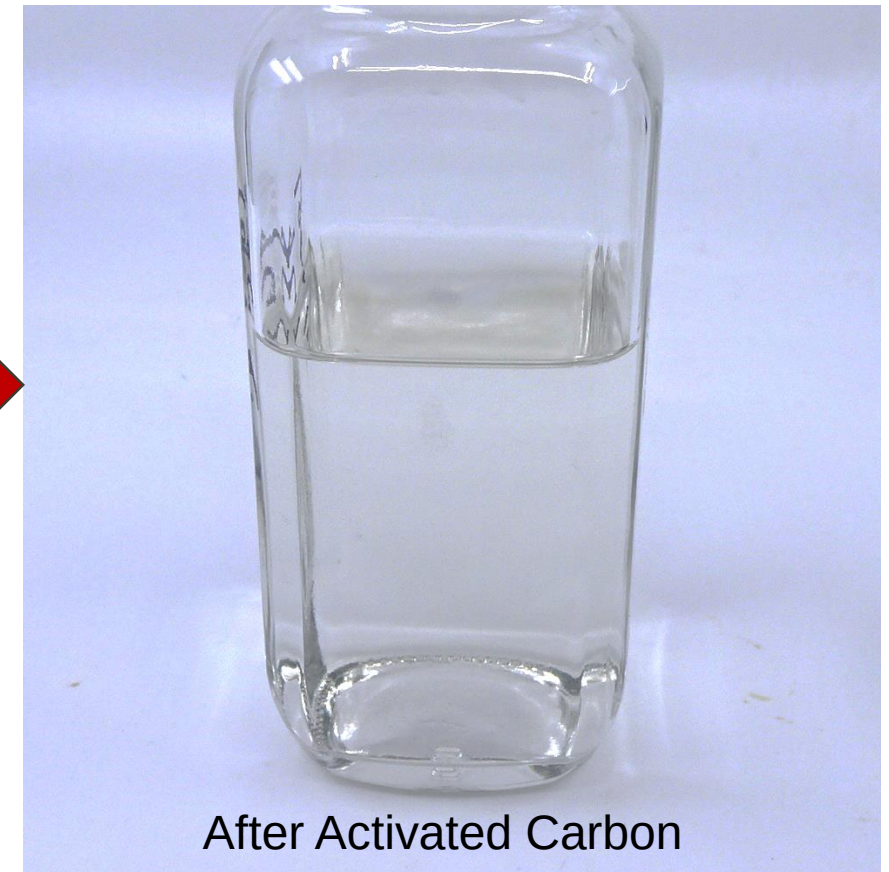
- The current iron sulfide particles cannot be removed with filters (0.45 microns) but activated carbon can help remove them (see picture).
- The colloidal iron sulfide particles will eventually agglomerate into filterable particles.

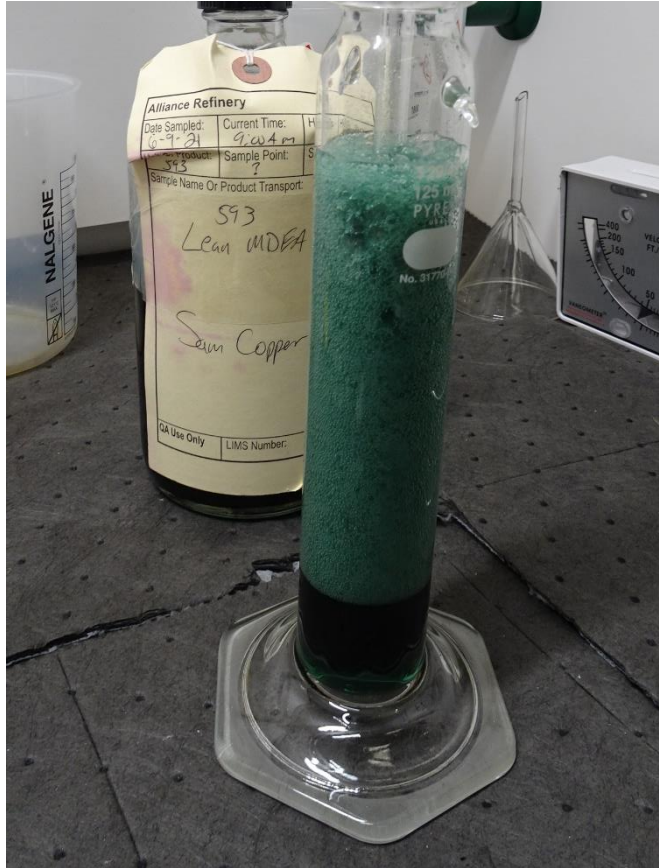
As received Lean Amine

- The as received lean amine shows a higher foam column compared with the amine after activated carbon treatment.
- Passing the lean amine through activated carbon helps remove organic compounds that contributes with foaming.

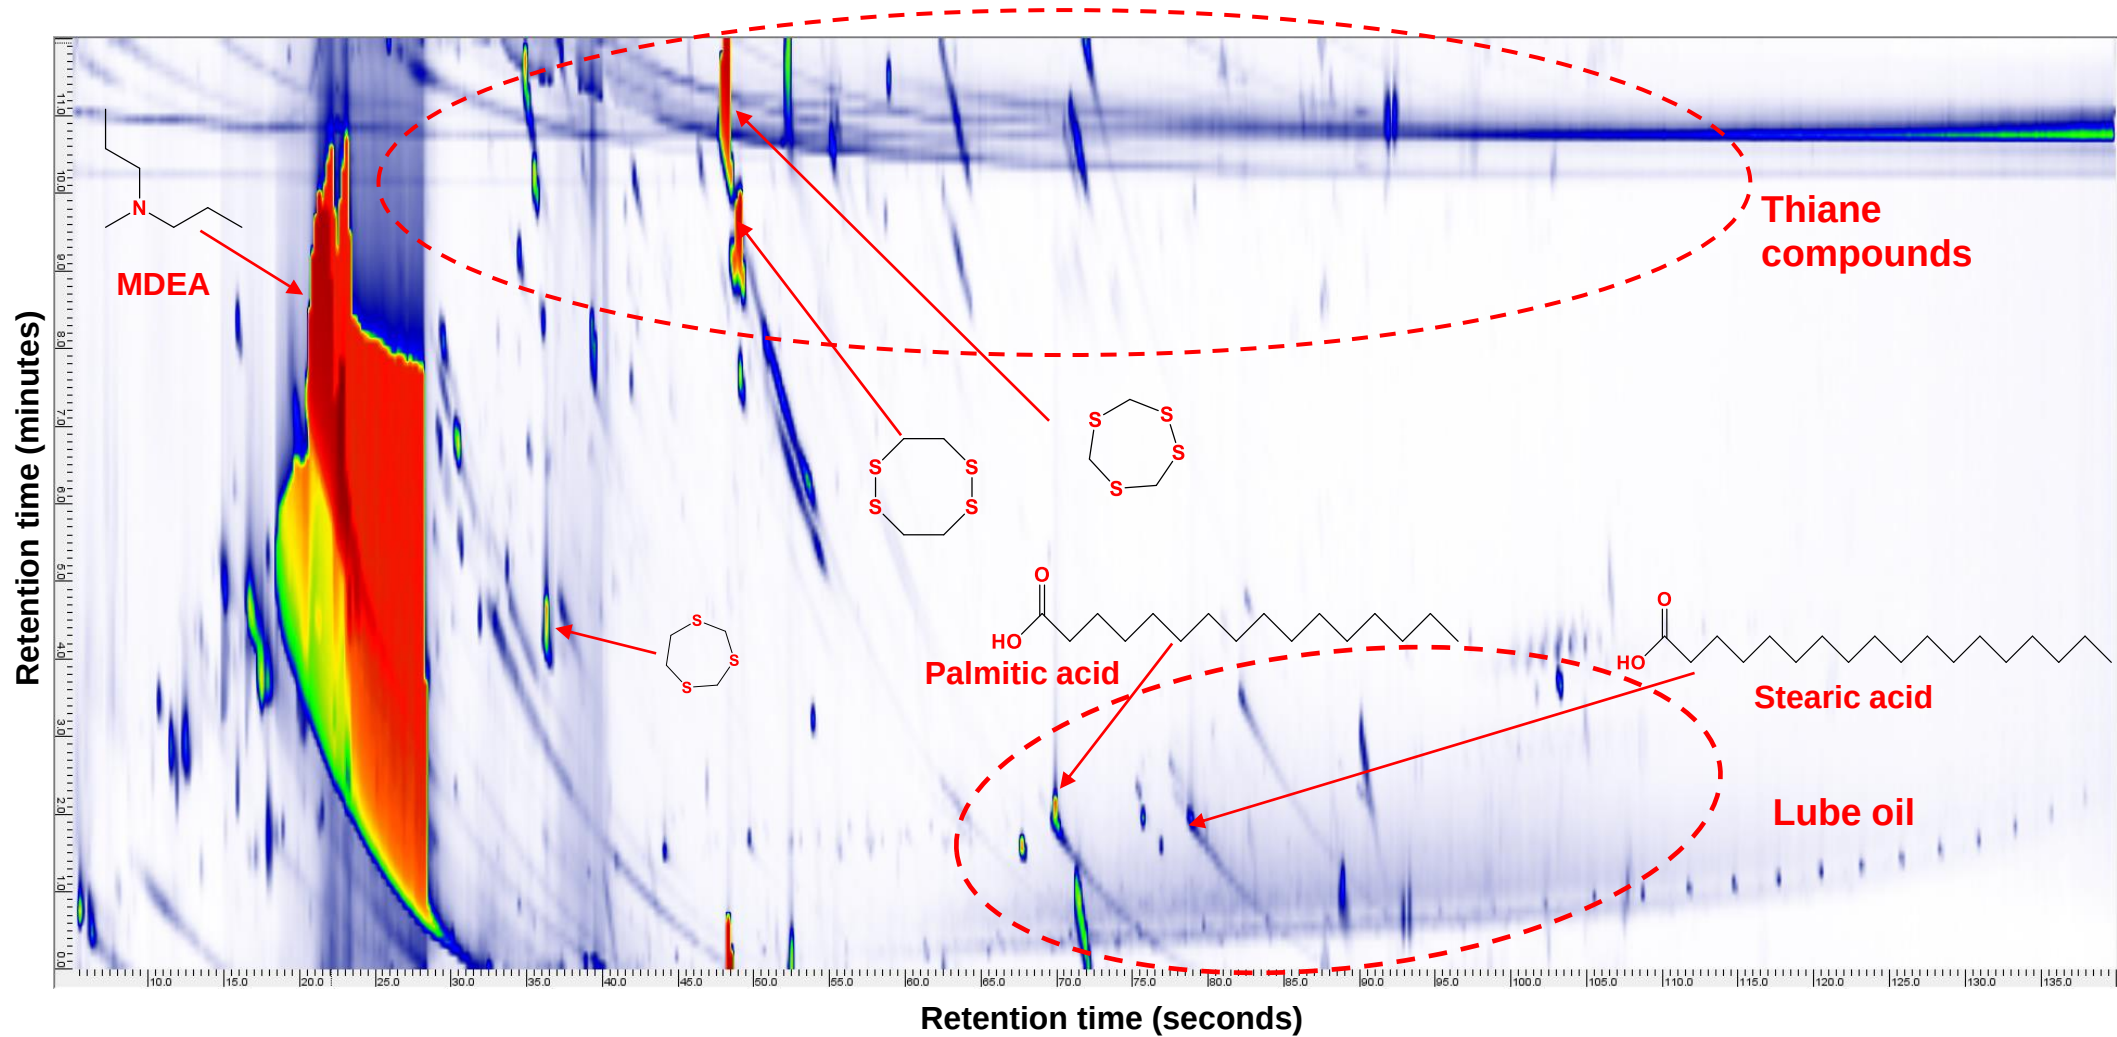
- The amine sample shows the presence of thianes, lube oil, palmitic/stearic acid (potentially rust inhibitor or metal working additives).
- The organic acids in the presence of the amine can form a salt that behaves like a surfactant (soap) and contribute to foaming.
