Amine Corrosion Troubleshooting with Acid Gas Enrichment Units

Virtual Vail | Thursday, September 17, 2020

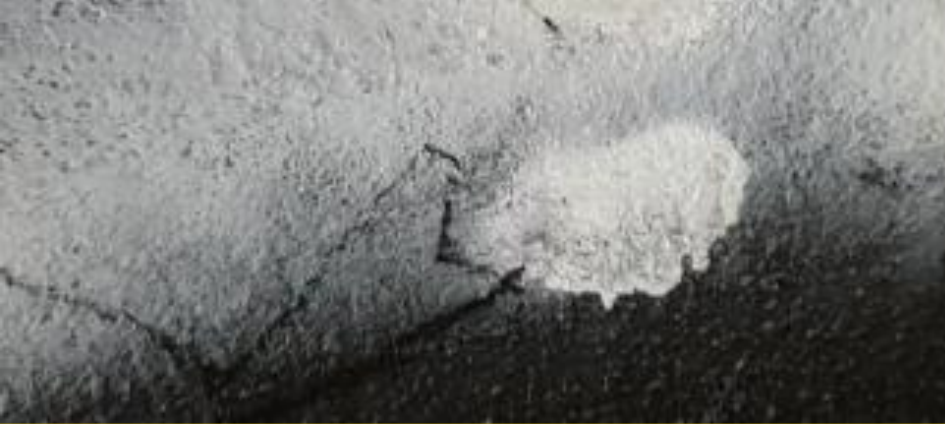
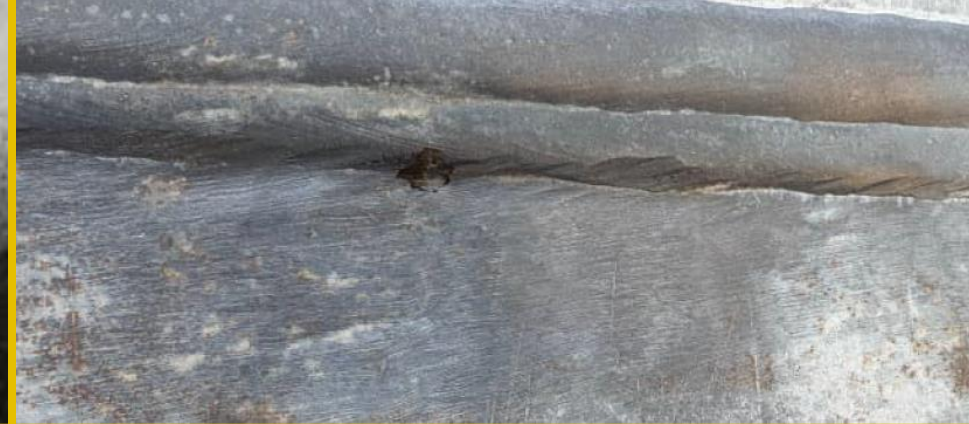
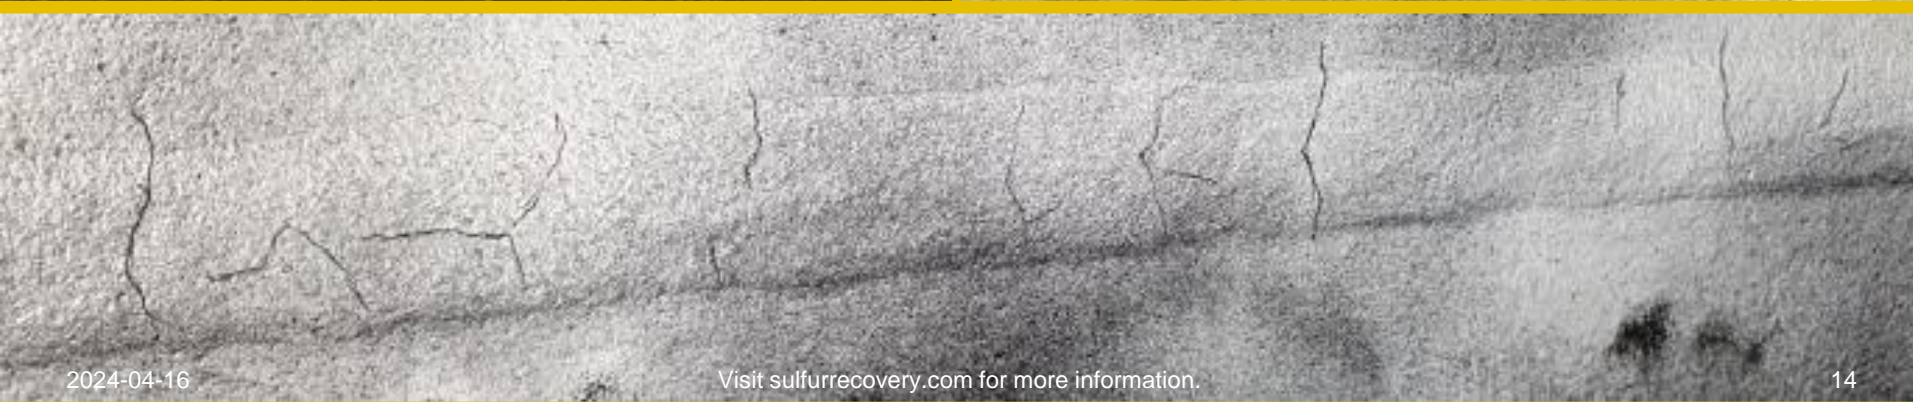
Cracking

- SRE brought in to troubleshoot “accelerated corrosion” within Acid Gas Enrichment Unit Regenerator column
 - Found localized cracking at circumferential welds
 - Number of cracks identified via Phased Array Ultrasonic Testing (PAUT) increased in a short time frame

- 2015: Train 2 Regen visual inspection negative
- Dec 2018: Train 3 Regen visual inspection negative
- May 2019: Train 2 Regen visual inspection, cracks apparent, PAUT scan completed
- Oct 2019: Train 3 Regen visual inspection, cracks apparent
- Nov 2019: Train 2 Regen PAUT scan again, more cracks

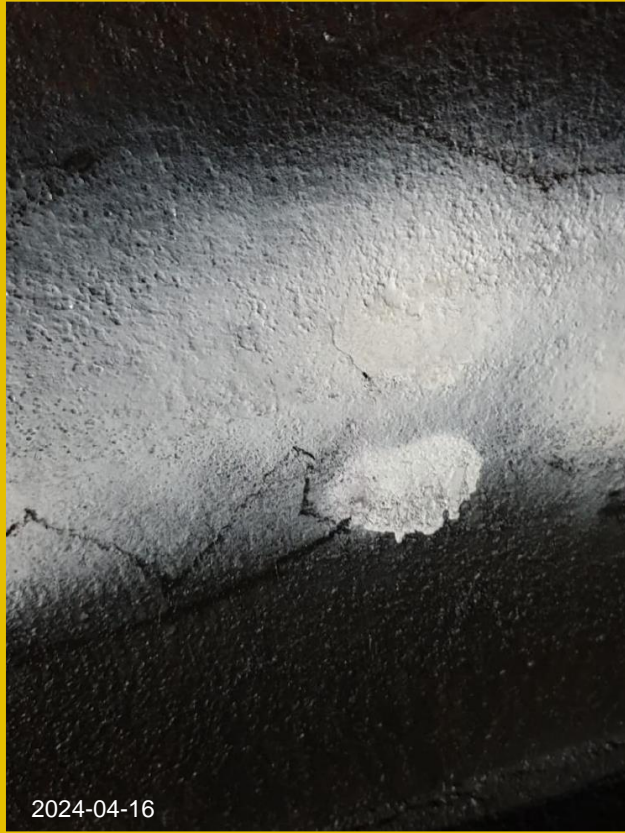
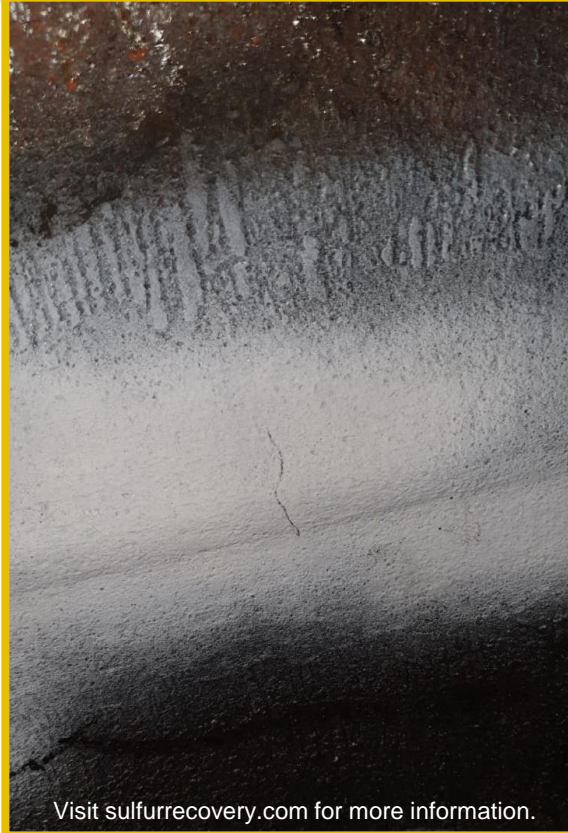
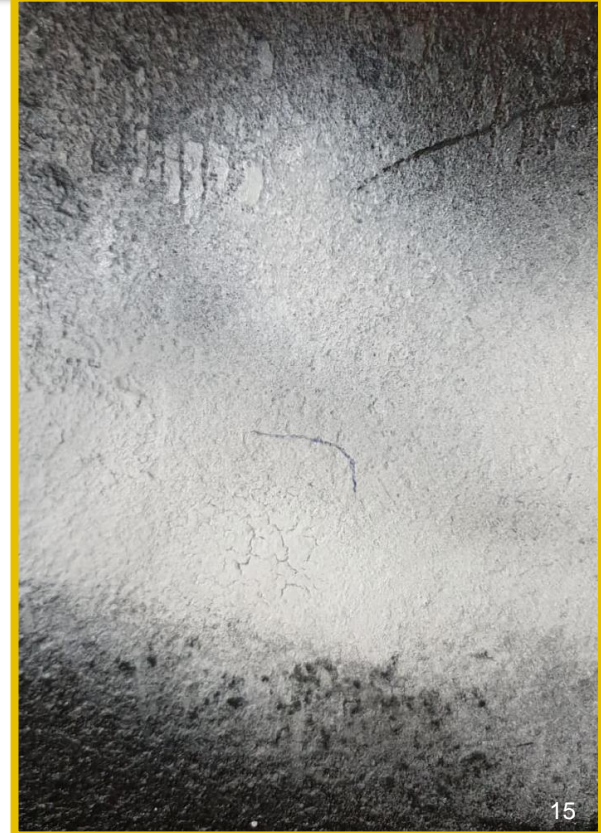
Cracking (cont'd)

- Evaluation of cracks was conducted to determine the angle
- Found 12% of the indications to be buried cracks
- Further crack type was determined to be chevron cracks and transverse cracks
 - Fabrication defect resulting from hydrogen that is produced in the weld by moisture of insufficiently dried welding materials.

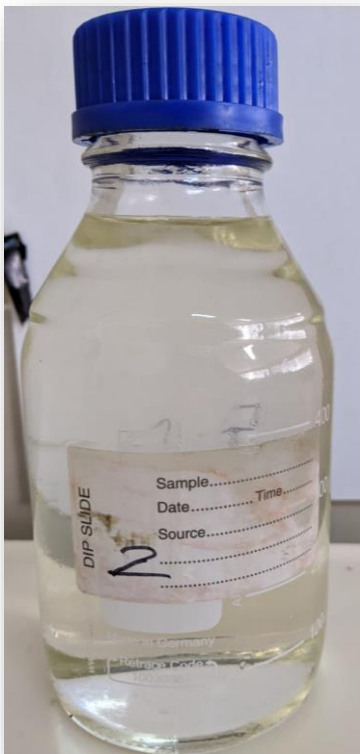
Lean amine concentration

Client requested investigation of low MDEA concentrations in high CO₂ applications

Rich loading found to be above 90% of equilibrium

Two phase flow was checked at outlet of reboiler valve and found to be 0.217% vapor

Acceptable for low corrosion
