TECHNICAL REVIEW: ENAP ACONCAGUA REFINERY SULFUR BLOCK

Brimstone Sulfur Symposium
September 11-15, 2023 – Vail, Colorado USA

ABSTRACT

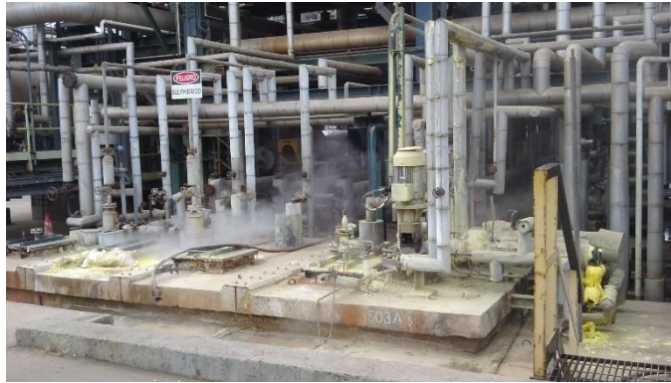
The sulfur pits T-1641 and T-3501 in URA2 and URA3 have the Shell Sulfur Degasification technology installed. The vent gas systems from both Sulfur Pits are plugged and there is evidence of a leak on the sweep air intake line in URA2.

Figure 2. URA3 Sulfur Pit

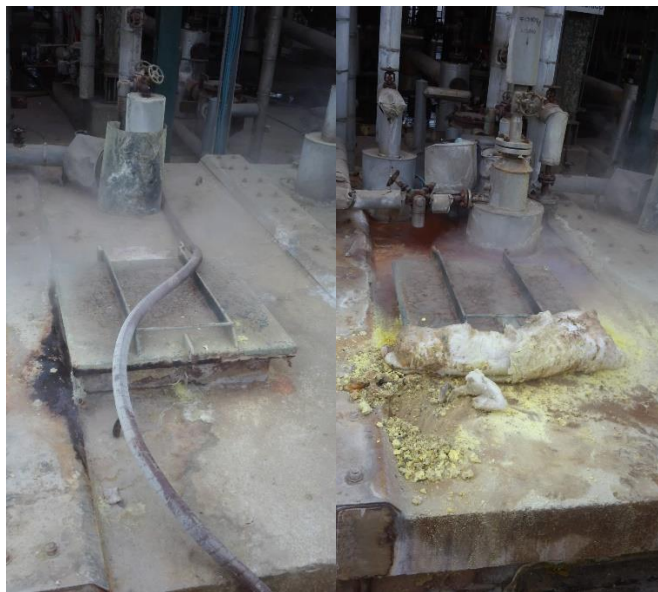
Figure 3. Vent air escaping from the access hatches in URA3 Sulfur Pit

As the stripping air flow to the sulfur pits bubble columns has not been stopped and the vent gas piping to the Thermal Incinerator was plugged, the vent air containing H₂S and SO₂ is released via the man access hatches in URA3 and the sweep air intakes in URA2. This is creating a situation with continuous release of H₂S to the atmosphere in excess of the maximum allowable concentration (MAC) of 10 ppmw. As a result, the areas around the sulfur pits are not safe and Comprimo recommended to take action to minimize access to these areas.

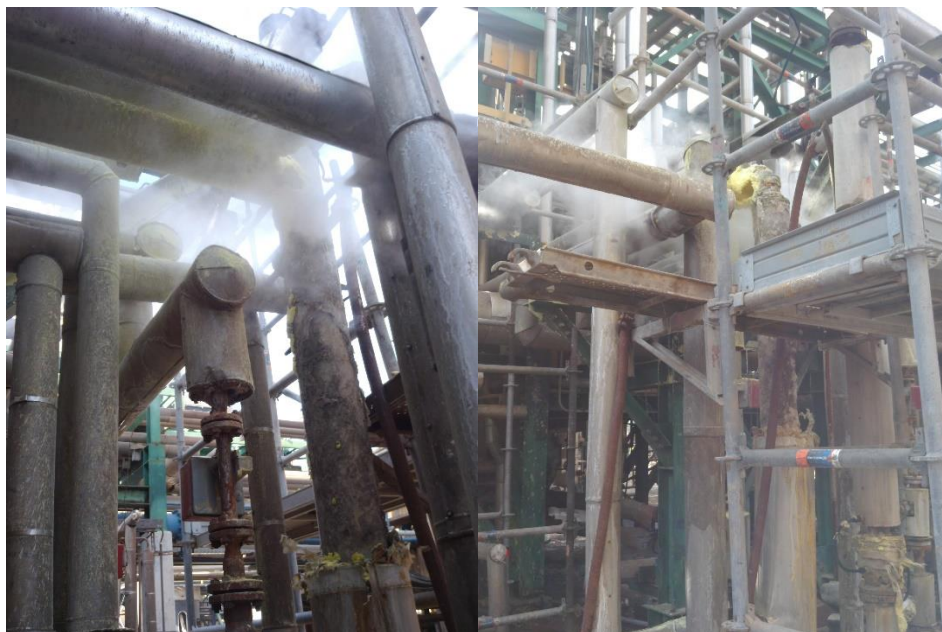
Figure 4. Vent air escaping from sweep air intake (left)/ leaking elbow on sweep air intake (right)

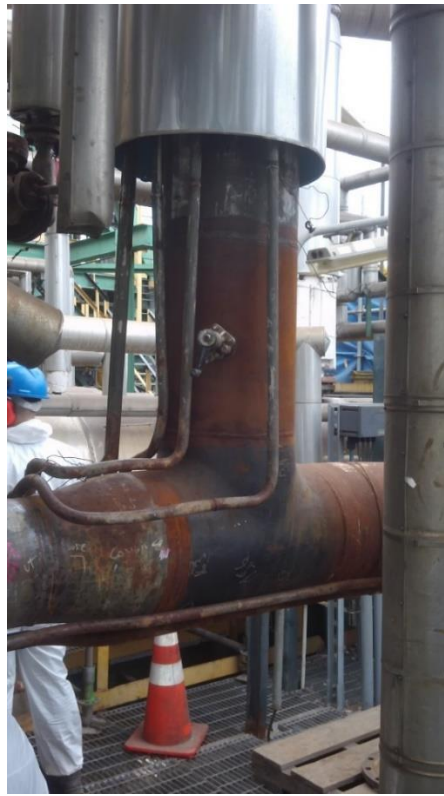
A portion of the sour water acid gas lines as well as the vapour lines containing sulfur appear to be traced with ¾" or 1" pipe tracers, which depending on the line size may have 2-6 tracers with often sections of insulation missing or no insulation at all on flanges. Most of these tracers did not touch the piping to provide direct conductivity of heat from the tracer to the pipe wall. Most of the interconnecting sour water acid gas piping between the sour water strippers and SRUs was jacketed, however due to

failed welds, the plant no longer kept the acid gas piping hot, resulting in substantial corrosion in the interconnecting piping.

Figure 5. URA2 Tail gas piping tracing.

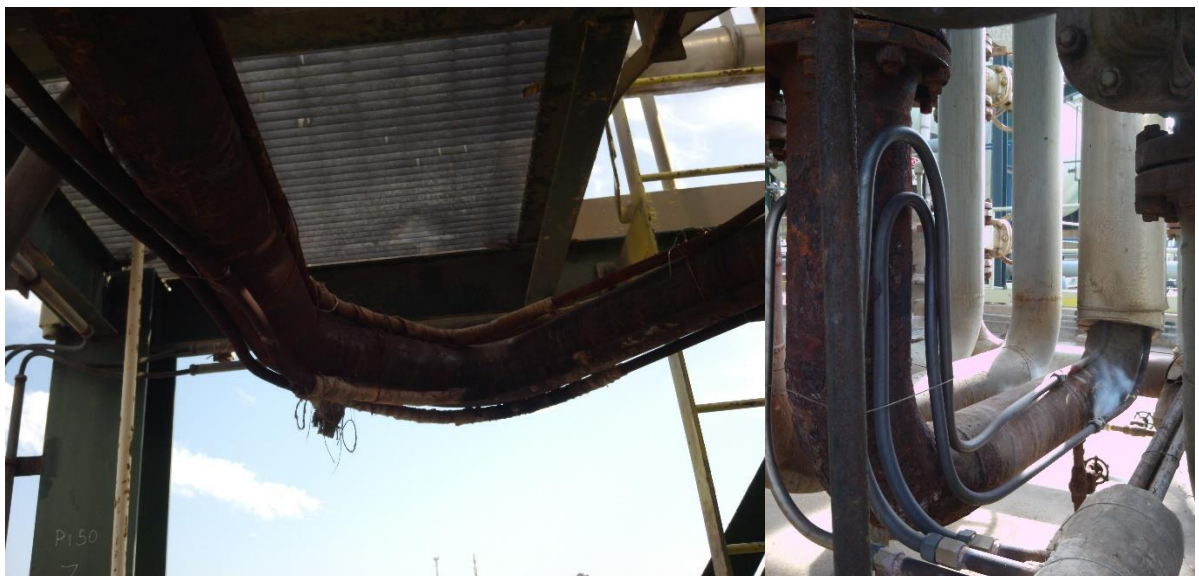
Figure 6. Sour water acid gas piping tracing.

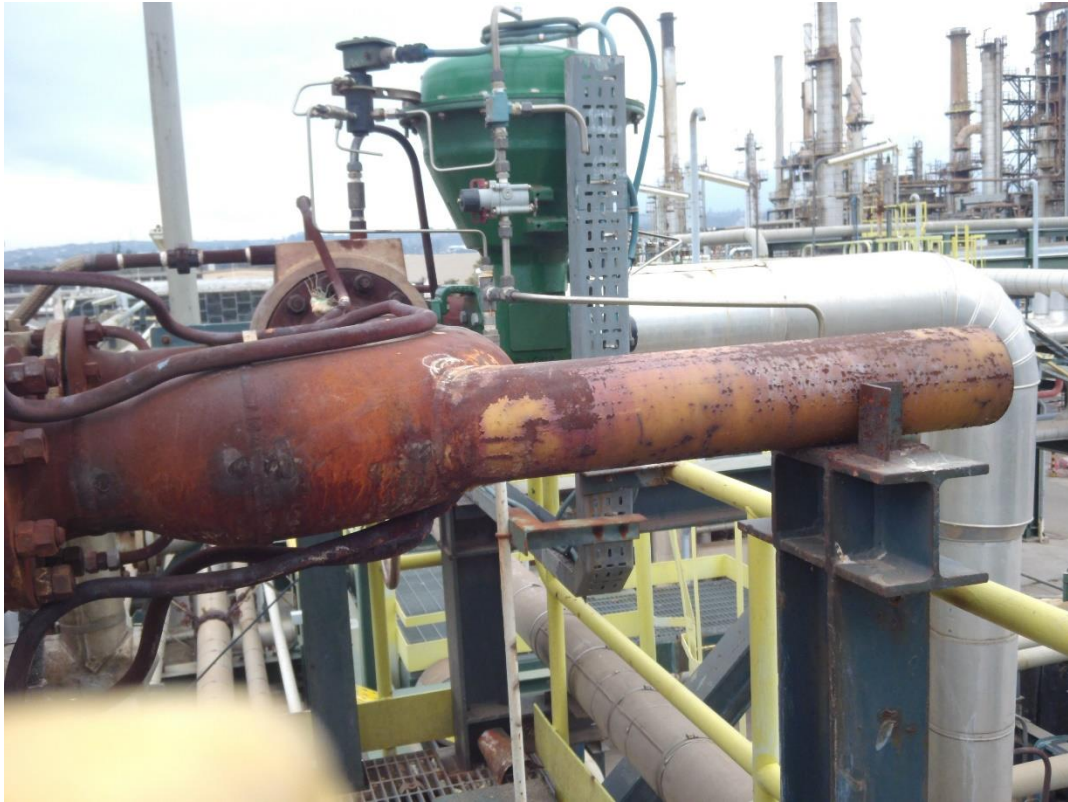
Figure 7. Tracing of vent gas piping including unheated pipe support.

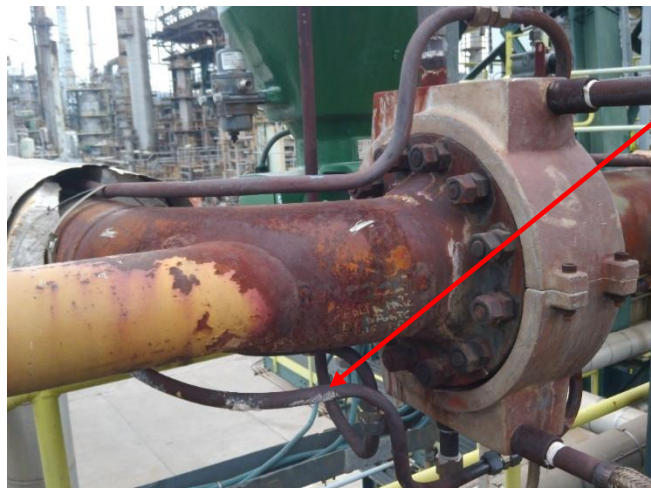
Flanges in these services act like very large heat sinks and must be traced as well. In practice it is not possible to get good contact between a tracer and the flange, and it is therefore recommended to install bolt-on jackets onto the flanges, which must be insulated. There were several examples found in the plant where these were installed, however the majority of the flanges in sour water acid gas and sulfur vapour service were found to be exposed to the atmospheric conditions.

Tracing does not touch piping

Figure 8. Bolt-on jacketing for flanges.

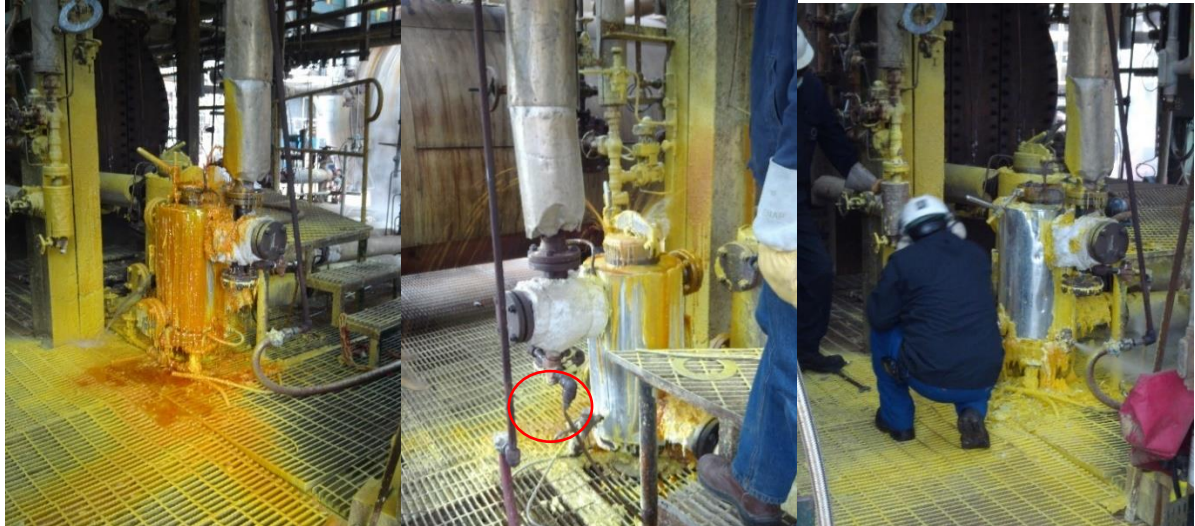
In the case of sulfur rundown lines, there appears to be a problem with the trap selection and the condensate return system. During the review, a freezing of one of the Sultraps in URA1 was observed first-hand with the event resulting in a substantial safety risk to the operators as well as a spill of sulfur to grade.

Figure 9. Consequences of frozen Sultrap in URA1.

Note in the second image the installation of the steam trap, which appears to be a thermostatic type with a 1/4" condensate return line with a severe bend at the outlet of the trap. As thermostatic traps operate on the basis of temperature difference, the condensate has to be subcooled before the trap opens, which will result in potential temperatures below the freezing point of sulfur. By removing the trap all together, the steam could flow continuously through the jacket resulting in the melting of the sulfur in the Sultrap. This is not a good practice and it was recommended to ENAP to do a full review of the steam and condensate systems for the heat maintenance in the sulfur recovery units.

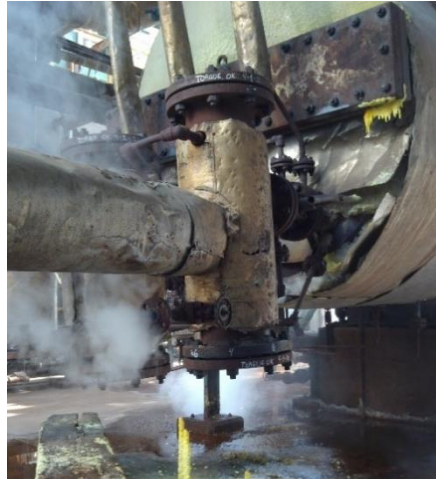
In URA2, it appears that several of the sulfur boots were modified to meet the slope of the rundown lines per the design requirements (1 degree slope), resulting in the inability to rod the entire sulfur rundown line into the condenser. Figure 11 shows the rundown sulfur boot for the third condenser.

Figure 11 - Sulfur Boot on Third Condenser

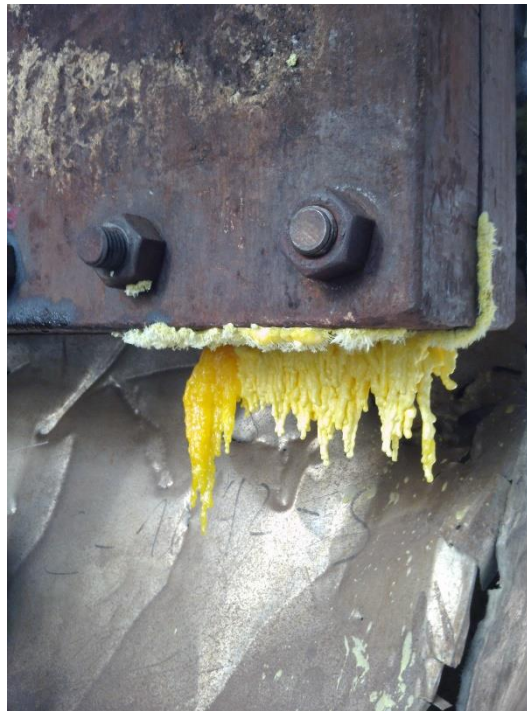
- Comprimo observed that the sulfur flow from the third sulfur condenser C-1644 was lower than the sulfur flow from the fourth sulfur condenser C-1645,
 - This is unusual as the sulfur production decreases as the process progresses.
- The sulfur rundown including the sulfur boot from the third condenser C-1644 were opened and checked for plugging and no evidence of plugging was observed in the rundown piping.
- A sulfur flush was performed, which did not appear to improve the sulfur flow.
- There was sulfur coming out of the demister box on C-1644. See also Figure 15.

Figure 15. Evidence of sulfur from the demister box in URA2 Third Condenser C-1644

Based on all the evidence above, Comprimo had strong suspicions that the poor performance of the catalyst in the URA2 third reactor D-1643 is caused by continuous sulfur carryover from the third condenser C-1644. As the rundown appeared to be open, Comprimo suspects that the sulfur carryover is caused by a partial blockage of the sulfur outlet nozzle in the outlet channel of C-1644, likely caused by a collapsed demister. Surprisingly the Inspection Report RS-GC-IF-04 from 09-07-2021 does not show any indication of issues with the demister, so the problem could also be caused by a partial blockage in the sulfur rundown isolation valve.

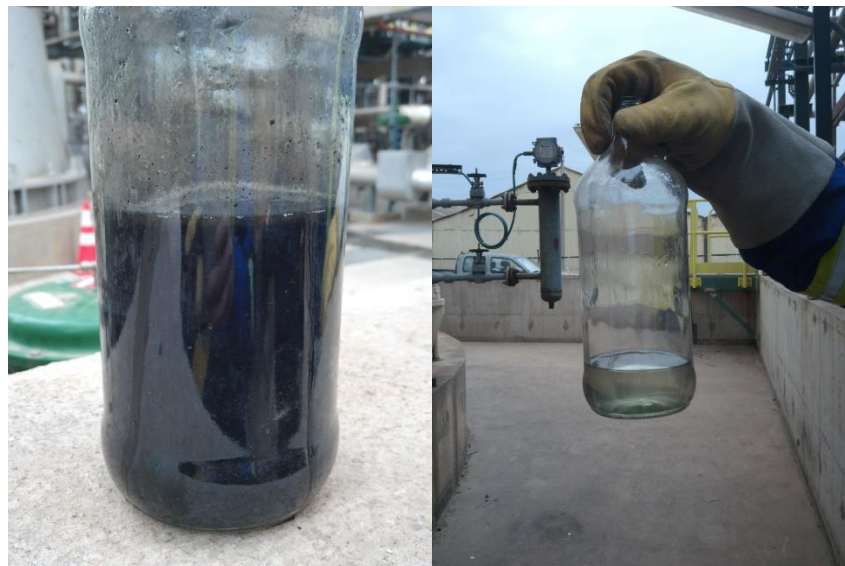
Comprimo inspected the amine stored in the Amine Surge/Storage Tank T-3201 and found the amine to be very dirty, even though operations indicated that the lean amine in the circulation is very clean as demonstrated in Figure 16.

Figure 16. Amine samples from Amine Surge/Storage Tank (left) and lean amine sample (right)

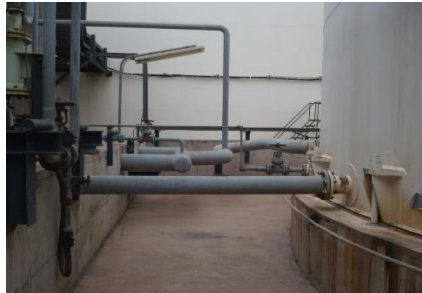
Upon further investigation, Comprimo observed that the Amine Surge/Storage Tank T-3201 was designed with the inlet and outlet nozzle located on the same side of the tank (see Figure 17) and hence Comprimo suspects that the lean amine is shortcutting through the tank. It is suspected that a substantial layer of sludge has built up in the tank.

Figure 17. Amine Surge/Storage Tank inlet and outlet nozzle

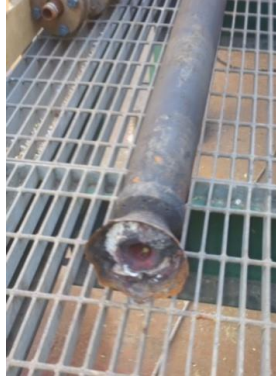
- The main burner was removed from the thermal reactor and the natural gas gun was removed from the burner
- There is indication of substantial back firing on the burner nose cone, resulting in damage to the nose cone.

Figure 21 - Natural Gas Gun and Nose Cone Damage

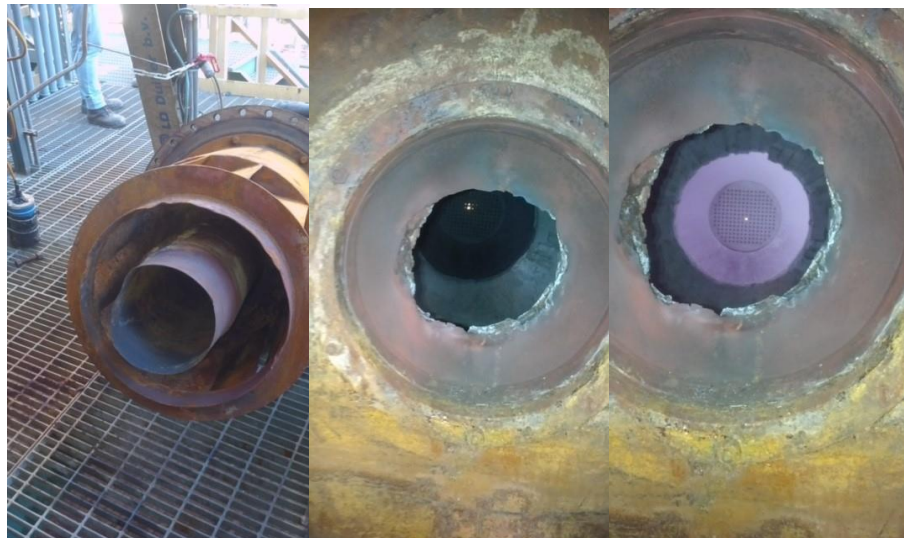
- There is also evidence of back burning on the opening into the mixing chamber as well as deformation of the nose cone of the air chamber, which can lead to bypass of air around the swirl vanes of the burner

Figure 22 - Main Burner and nose cone into the Mixing Chamber

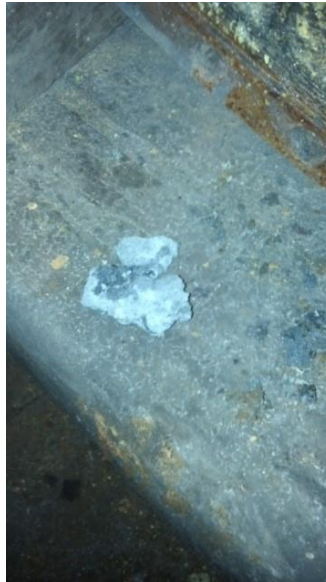
- The outlet channels of all three condensers were inspected and it was found that especially the second and third condenser showed a large build-up of foreign material that does not appear to be sulfur.

Figure 23 - Foreign Material in the Outlet Channel of the Second Condenser

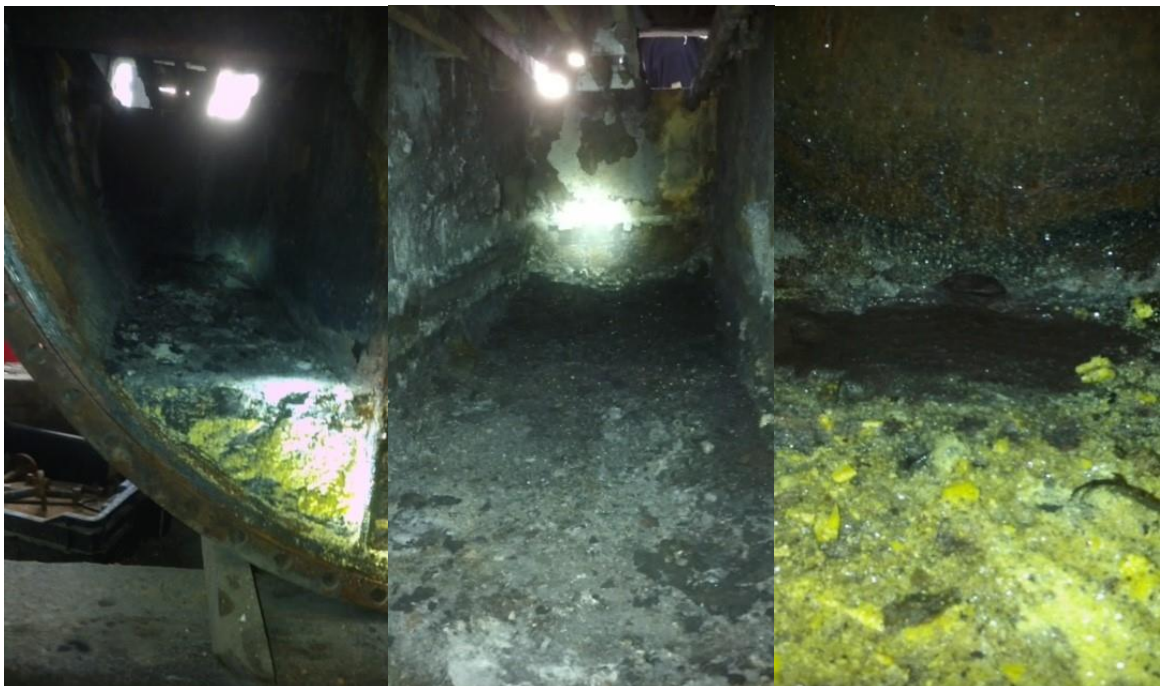
- In addition, the foreign material was partially to fully blocking the sulfur rundown nozzle in the outlet channel for the second and third condenser

Figure 24 – Second and Third Condenser Outlet Channels

This is expected to be the main cause of the poor performance of URA2. As the sulfur cannot flow properly out of the second and third condenser, sulfur is carrying over to the second reactor as well as the third reactor. During the technical review in 2022, there was evidence that liquid sulfur was draining down the catalyst. The temperature profile in the third reactor showed evidence of sulfur vaporization in the catalyst.

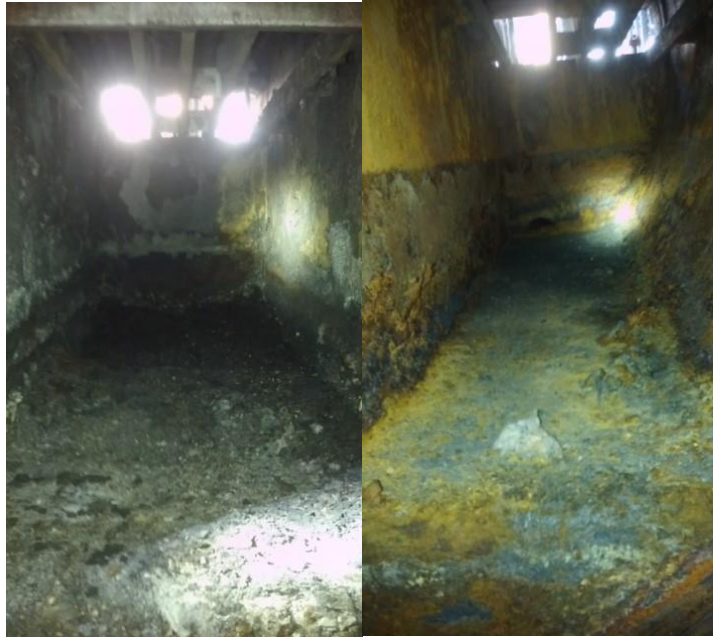
Figure 25 -Second and First Condenser Outlet Channels

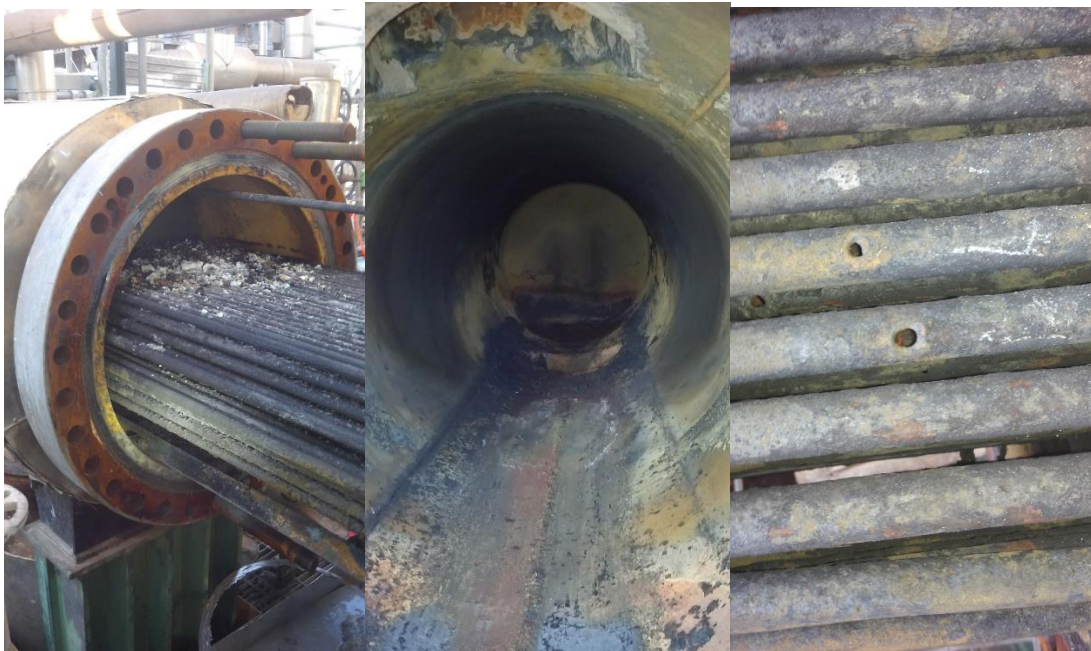
The second reheater had experienced a leak in the tubes in January of 2023 and upon inspection, it was observed that three tubes had been plugged. There also was evidence again of debris and soot in the shell and on the tubes of the reheater.

Figure 26 -Second Reheater Inspection

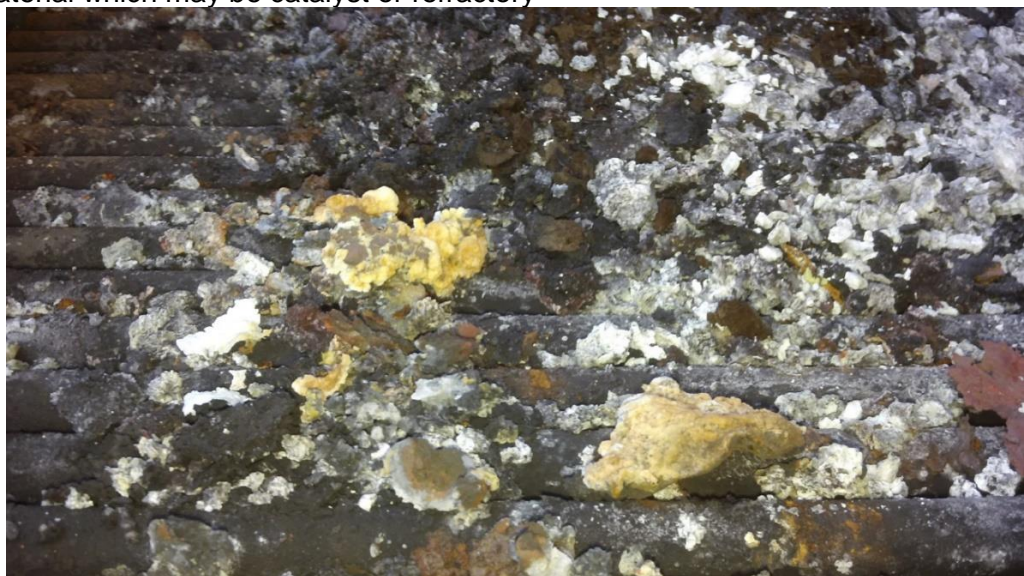
- Substantial fouling was observed on the shell side of the reheater as well as fouling of the tubes
- There was evidence of some elemental sulfur in the fouling material, however there was also evidence of black material that appeared to be potentially soot as well white material which may be catalyst or refractory

Figure 27 - Fouling material on tubes third reheater

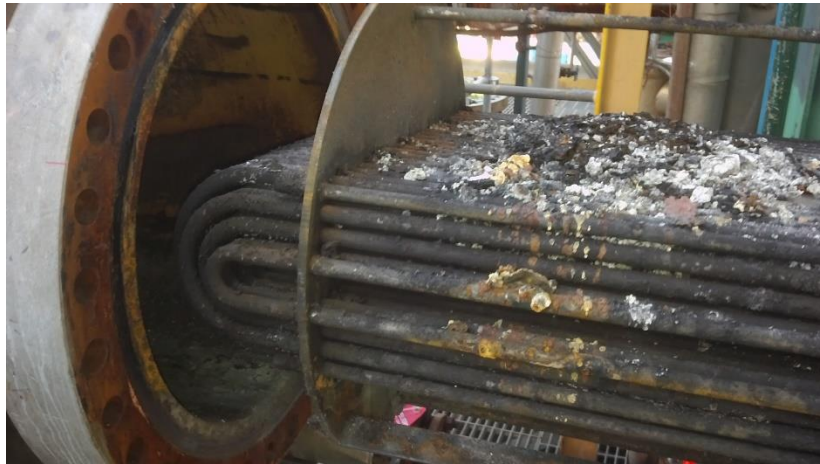
- The inlet nozzle appeared to be full of a fine black material after the pulling of the tubes. This could be either iron sulfide or even soot based on the findings in the reactors. The amount of fouling material is substantially higher than typically expected in a third reheater.

Figure 28 - Fouling on third reheater tubes

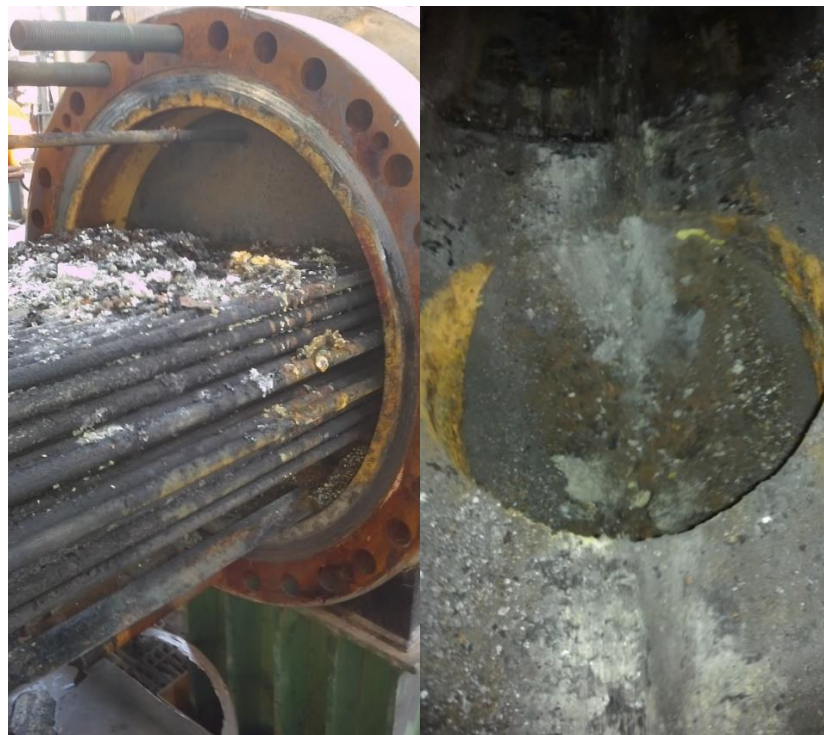
Figure 29 - Fouling on third reheater tubes/fouling in inlet nozzle third reheater

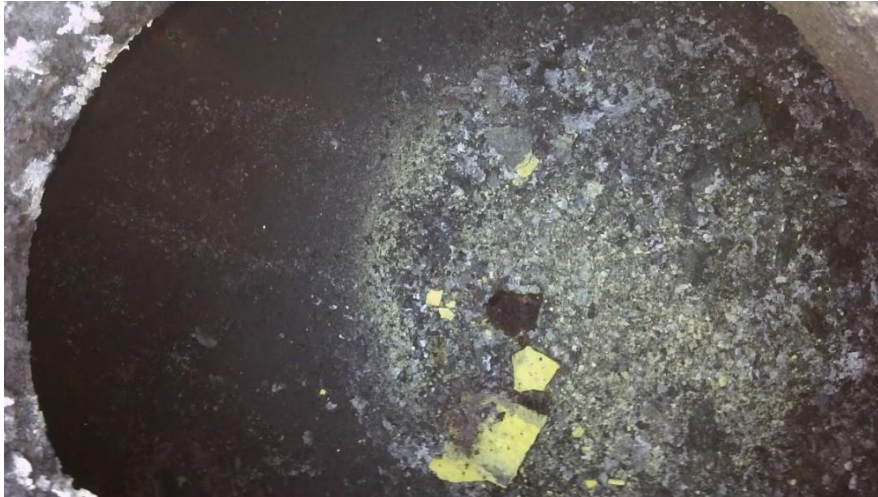
Figure 31 - Top view catalyst second reactor

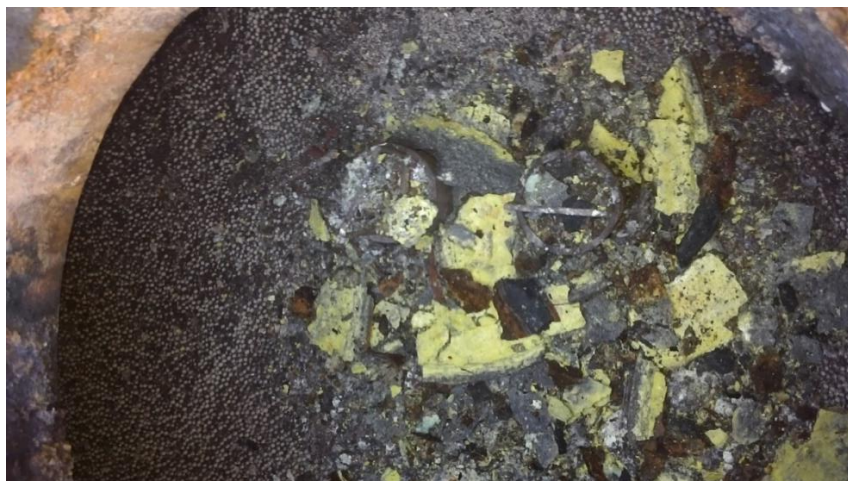
- There is evidence of sulfur on top of the catalyst in the third reactor as well as some soot
- Comprimo provided the following recommendations:
 - Remove and replace the catalyst. Determine the depth of the soot in the catalyst bed. Remove the sample baskets from the reactor for catalyst sampling
 - Observe the catalyst damage on both sides of the reactor. During operation there was evidence that there was preferential flow of potentially sulfur (as evident from the plugging of the sulfur outlet nozzle in the third condenser) to one side of the Third Reactor

Figure 33 - Top View Catalyst Third Reactor
