# **Pure Evil – Tall Tales of the Most Heinous Hydrocarbons in Refinery Amine Systems**

*Brimstone Vail Sulphur Recovery Symposium  
Sept 11-15, 2023, Vail CO USA*

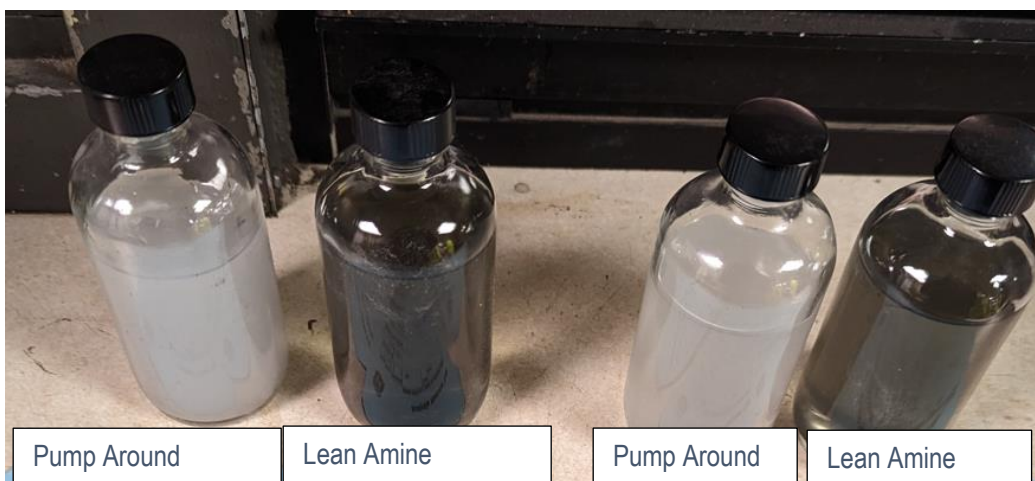
**Figure 1** Amine Condition Morning of 3/13/2023

A picture showing the condition of the amine on the morning of the event is shown in Figure 1.

The grayish ARU pumparound purge samples are indicative of an emulsion of hydrocarbon, particulates and anti-foam. The lean amine from one system was dark black indicating macroscopic iron sulfide particles. Color of the second system lean amine was a little better, but the cloudiness indicated heavy hydrocarbon.

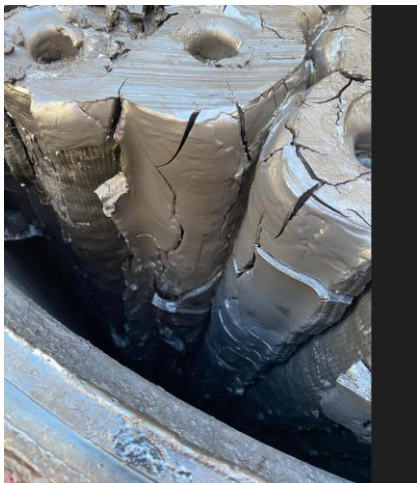
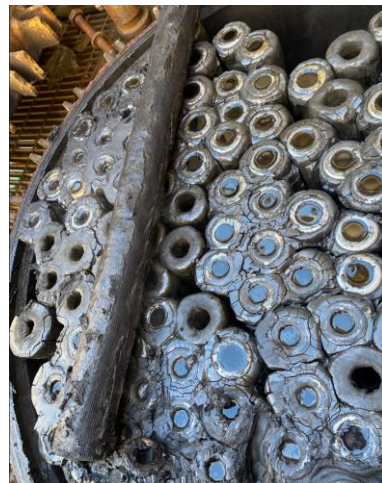
## Figure 2 Filter Elements from One Amine System

Lean amine into and out of each cartridge filter was sampled and the filters were found to be ineffective despite low pressure drop 2-3 psi. One filter was found to be completely plugged with several feet of sludge in the bottom. Pictures of the elements follow in Figure 2.

Samples of the solids were sent to Phillips 66 Energy Research and Innovations (ERI) laboratory in Bartlesville for further characterization. Note that flow indication to the filters did not exist for operations to know whether the filters were seeing flow.

Particle filter elements on the dirtiest system were changed out on 3/16 and the amine looked visibly better the next day. Particle filters on the other two systems were subsequently changed several days later.

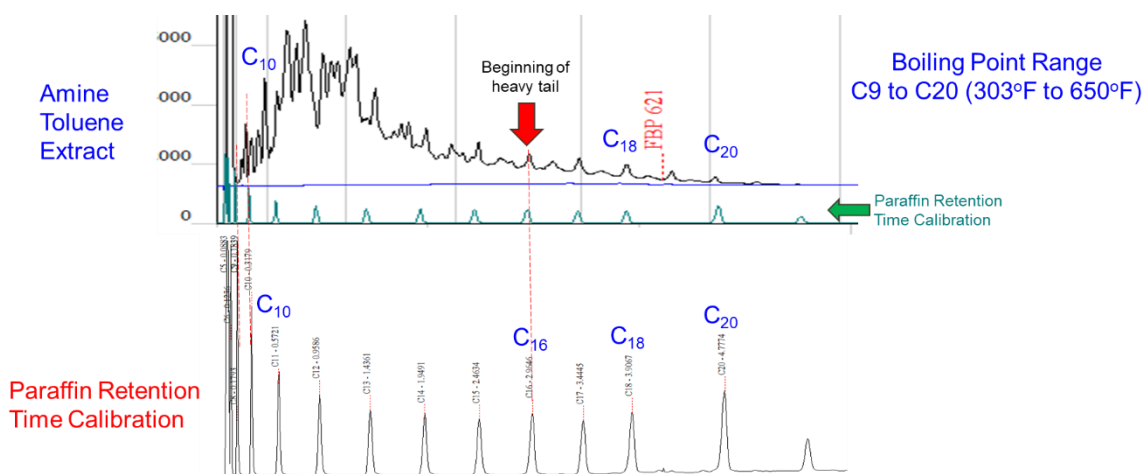
**Figure 3 Chromatogram of Hydrocarbon Liquids Extracted from Pumparound Water**

Figure 3 shows the GC SimDist Chromatogram of the hydrocarbon extracted from the pumparound water showing a boiling range between C<sub>9</sub> (303°F) and C<sub>20</sub> (650°F). However, the overall profile (C<sub>9</sub> to C<sub>16</sub>) is most consistent with kerosene boiling range material with a slight heavy tail of C<sub>16</sub><sup>+</sup>. It is somewhat unusual that the paraffin peaks are relatively small for a straight run distillate, indicating that this material could be a product from a cracking unit. The heavy tail may have been an indication that there is a separate diesel range material present.

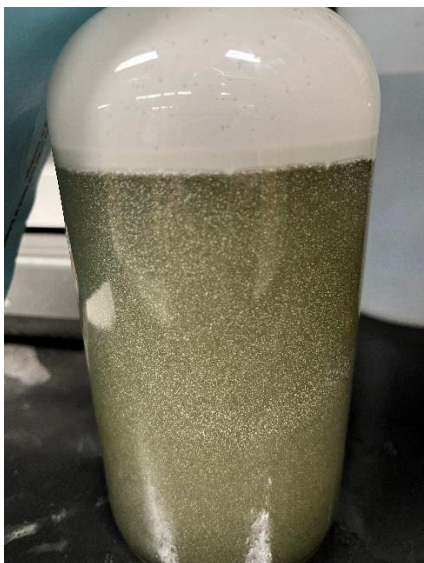
**Figure 5 Contaminated Regenerator Pumparound Water Sample**

Samples of rich amine from all Contactors along with the contaminated ARU Regenerator pumparound water were processed in the refinery lab and at ERI in Bartlesville to be fingerprinted. Figure 5 shows a picture of the pumparound water skimmed material the day that it was pulled taken in the refinery lab while being stirred.

The sample shown in Figure 5 was torn apart in the ERI Bartlesville laboratory using several tests. Figure 6 shows the fingerprints from comprehensive two-dimensional gas chromatography mass spectrometry (GCxGC MS) analysis of the top and bottom layers of the sample compared to a sample of the light coker gas oil that is used as a lean oil upstream of the Coker GRP fuel gas absorber. There is a definite match of a portion of the spectrum.
