Thermal Reactor Refractory Enhancements for O₂ Enriched Service

Presented at the Brimstone Sulfur Symposium
September 12-16, 2022 at Vail, Colorado

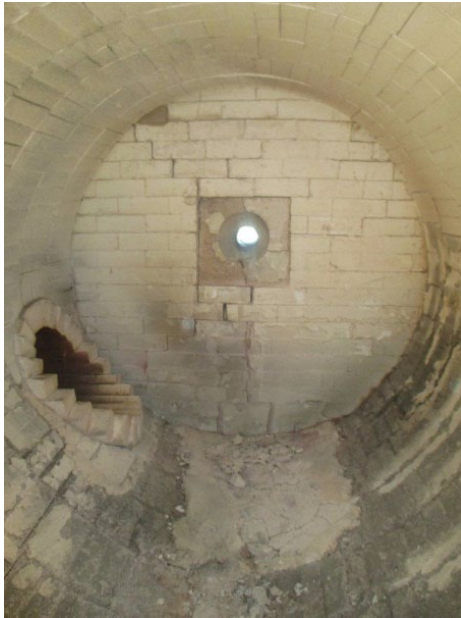
Figure 3

During past inspections, the flat endwall refractory has often been found to have major cracks as displayed in Figure 3, and sometimes bricks found fallen off as in Figures 4.

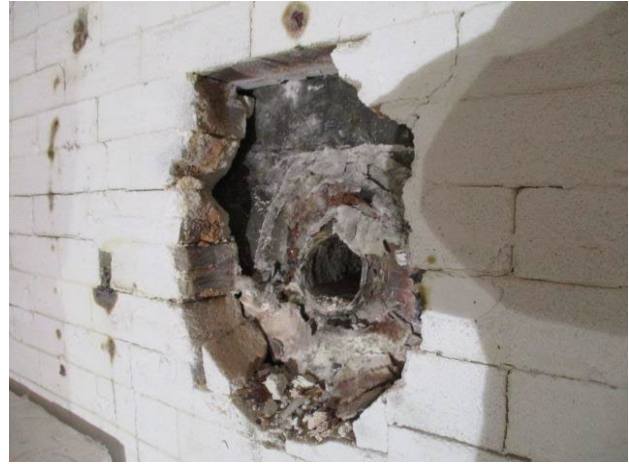
Figure 6

At times, even when an initial inspection of the flat endwall appeared good, it turned out to be not as good, as displayed in Figures 5 and 6. The flat endwall refractory in Figure 5 appeared to be in good condition at first glance, but was found to have major issues as shown in Figure 6. The inspection report findings were as follows.

“Thermal imaging of the endwall prior to unit shutdown indicated a hot spot around the viewport nozzle. Upon entry, after unit shutdown, a hammer test of the brick indicated a void in the lining. Subsequent removal of the hotface brick revealed a 1” to 1-1/2” separation between the insulation bricks and the hotface bricks as the hot face bricks bowed inward. Metallic anchors tying the service lining to the shell were found to have failed, with some of these anchors having burned up. Even though the overall condition of both bricks was determined to be in serviceable condition, approximately 65% of the flat wall refractory had to be removed to repair the anchors.”

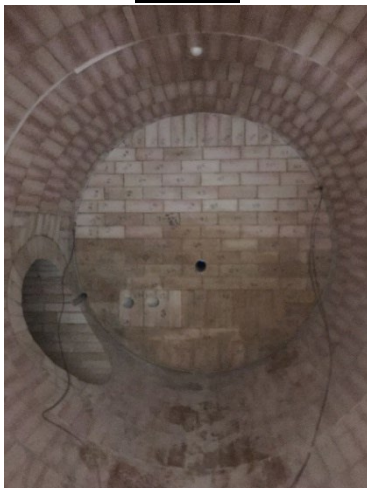
Figure 9

During 3rd quarter of 2018, SRU #2 entered a scheduled outage as part of the Modernization Project modifications. The newly fabricated thermal reactor vessel with a shop installed flat refractory lining was installed as displayed in Figure 9. The outage was completed during mid-4th quarter 2018. The new refractory was dried out per manufacturer's recommendations. The unit was successfully commissioned and started up with air only. Upon start up, the flat endwall displayed a more uniform temperature profile without any hot spots, as displayed in the thermal image in Figure 10.

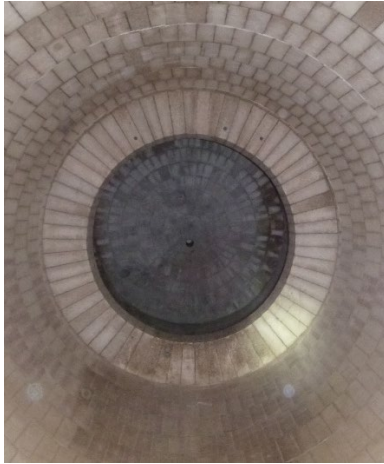
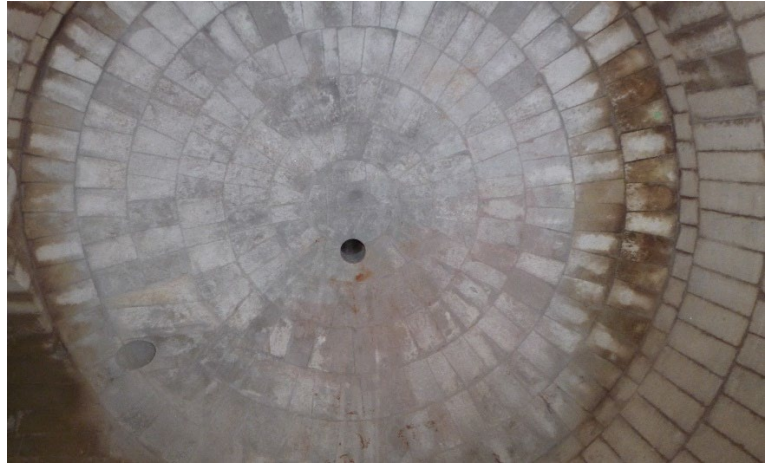
Within approximately one week of being contacted, Thorpe had technical discussions with Chevron Richmond, started the drawing design, found and shipped brick to site and mobilized to begin the modifications. Thorpe removed the existing lining (new flatwall) from the endwall, including the cylinder lining thru the burner connection in a local shop near the plant. The new Thorpe Houston shallow cone lining was installed in the vessel and handed back to the plant for the vessel to be installed in the unit. The newly installed shallow cone refractory is displayed in Figures 14 and 15.

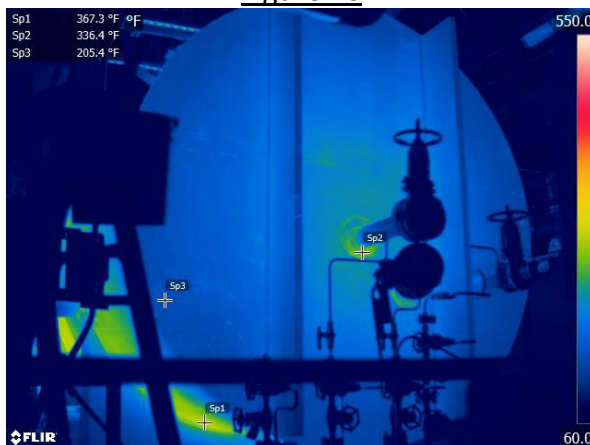
Figure 16

A proper heat up and dryout of the refractory was performed on SRU #1. A successful startup followed soon after. The shallow cone refractory yielded a very uniform thermal profile when SRU #1 started up and operated with air as displayed in Figure 16. There were no hotspots to be found. Shortly after startup, oxygen was introduced into SRU #1. The acid gas feed rate reached close to the design with oxygen enrichment. The flat endwall still displayed a rather uniform thermal profile as displayed in Figure 17.

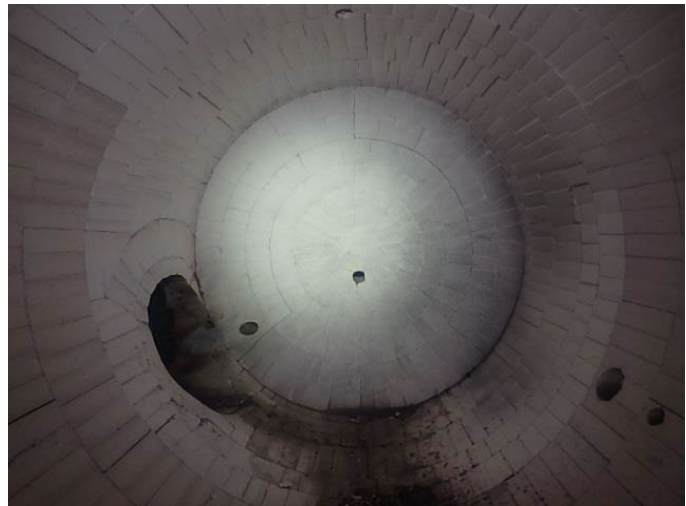
Figure 18

In 4th quarter 2021, SRU #2 was taken down for the 3-year boiler recertification inspection. After 2 years of operation with intermittent oxygen enrichment, the shallow cone refractory on the flat endwall held up well, as displayed in Figure 18. The internal inspection noted the shallow cone refractory to be in serviceable condition with minor cracks (mortar joint separations) of up to a 1/16" in width. Such small cracks are not unusual and will close up in operation.
