Successful Operation of SRU with Condenser(s) Bypassed

2022 Brimstone Sulfur Symposium - Vail

Lost Cabin Gas Plant

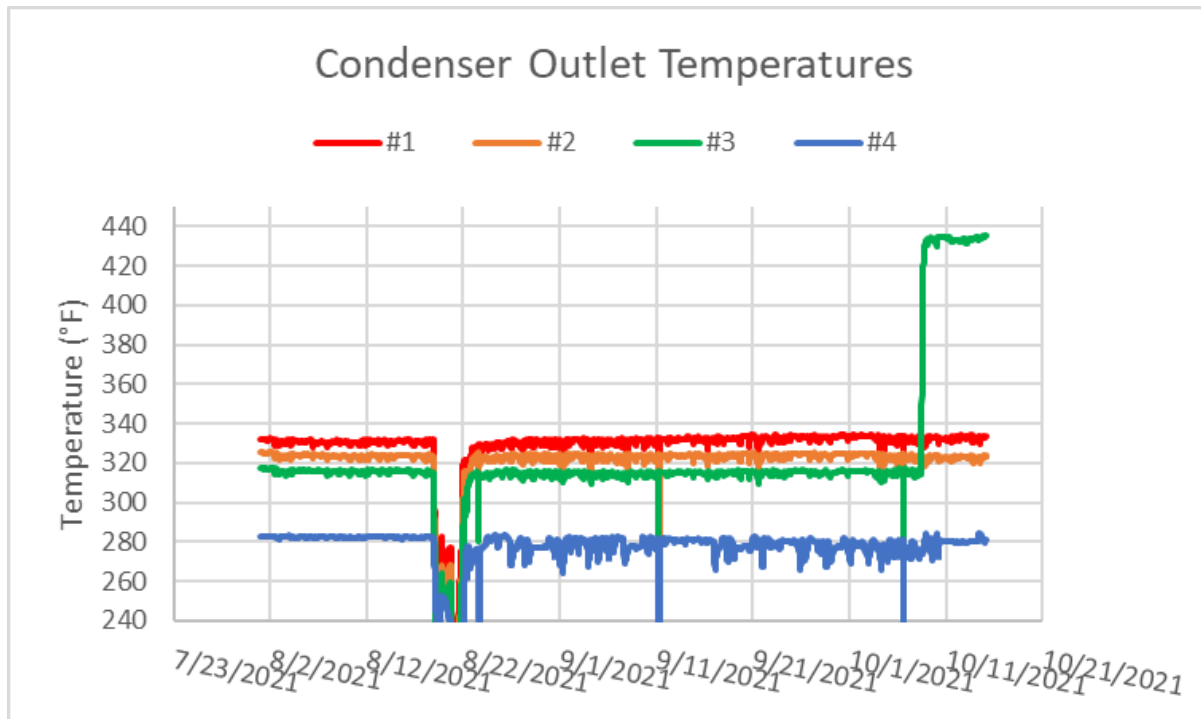
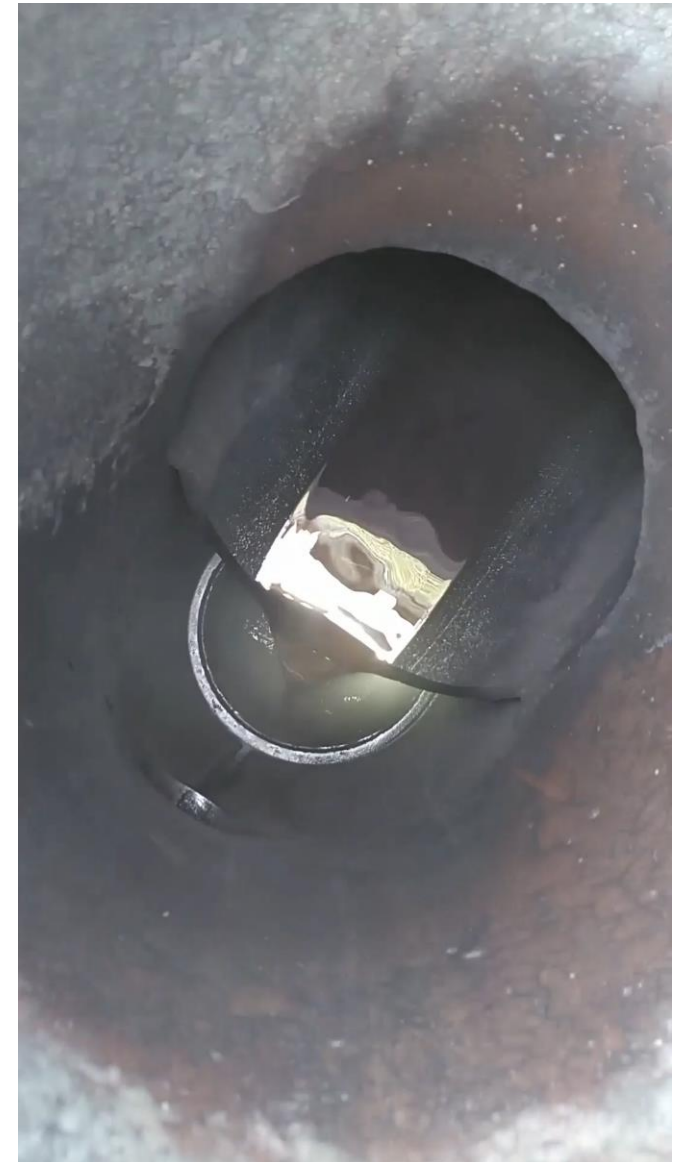
Decision to Continue Running

- Initially seemed to alleviate issue
 - Outlet temperature had stabilized
 - Load shifted to #4 condenser
 - Continuous flow of good quality sulfur

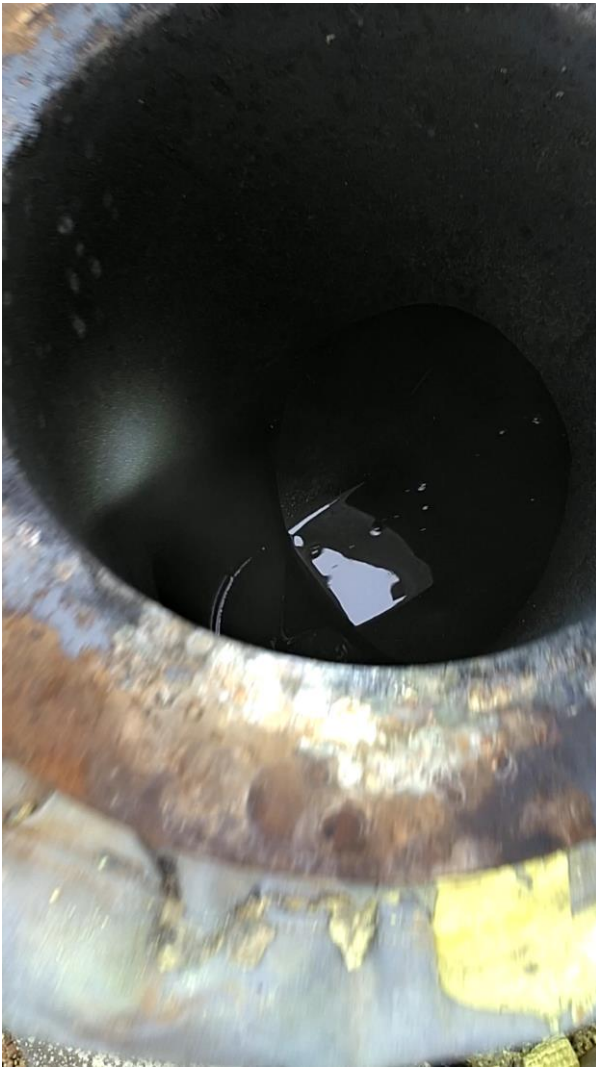
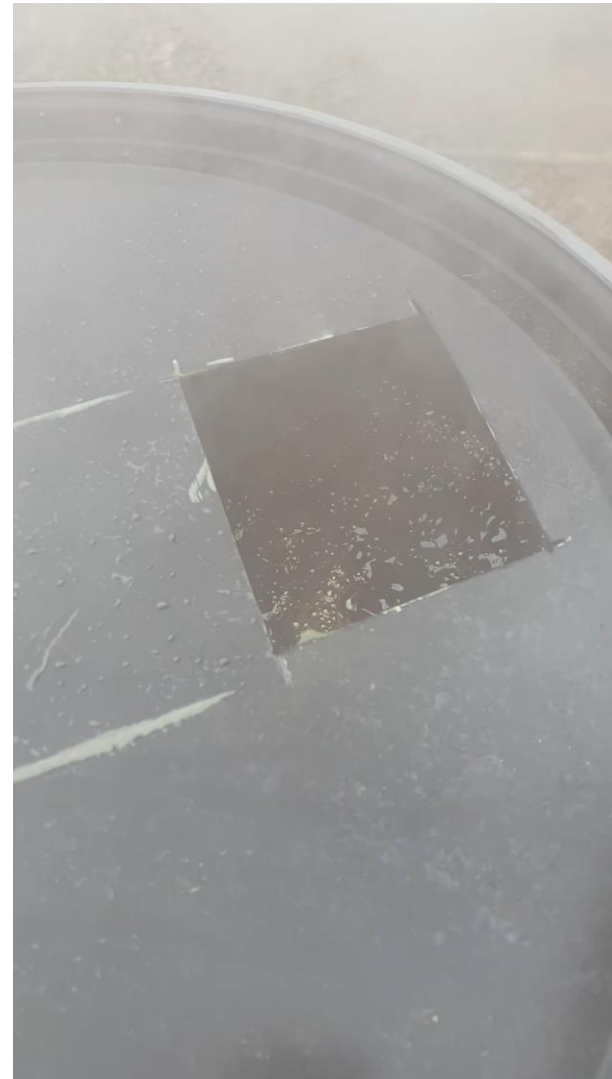
Issues Resumed

- Within ~1-2 weeks, continued to have similar issues, evidence of water
- Tested #3 condenser; shell side holding steam pressure
- Could not put #3 condenser water back in service with unit online

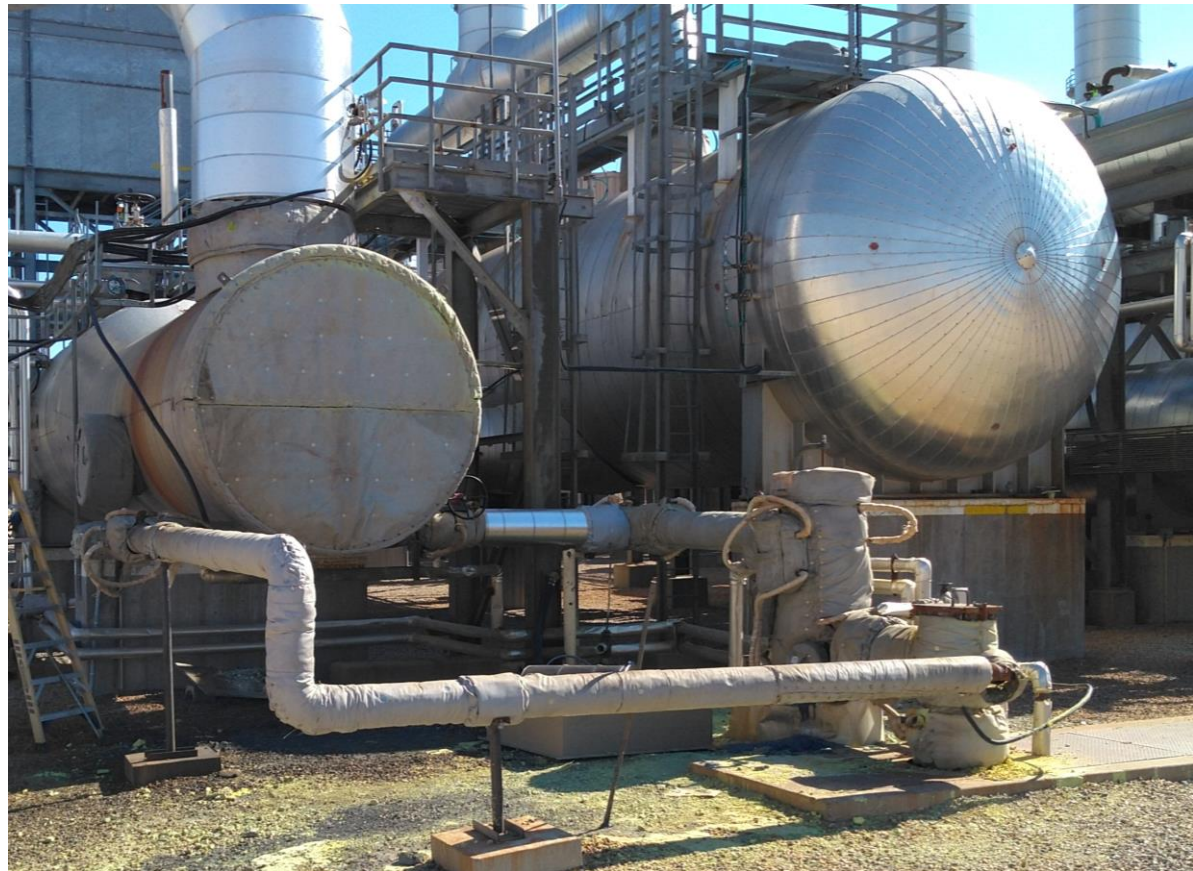
Issues Resumed

- Decided to continue in current operation mode
 - Sulfur seal has jacketed bypass, allowing for manual draining
 - Sulfur pit ~16 hr residence time, remaining water should boil off
 - Corrosion should be limited if temperatures are maintained
 - Inspect pit during turnaround
 - Developed procedure to 'swap' if opportunity arose

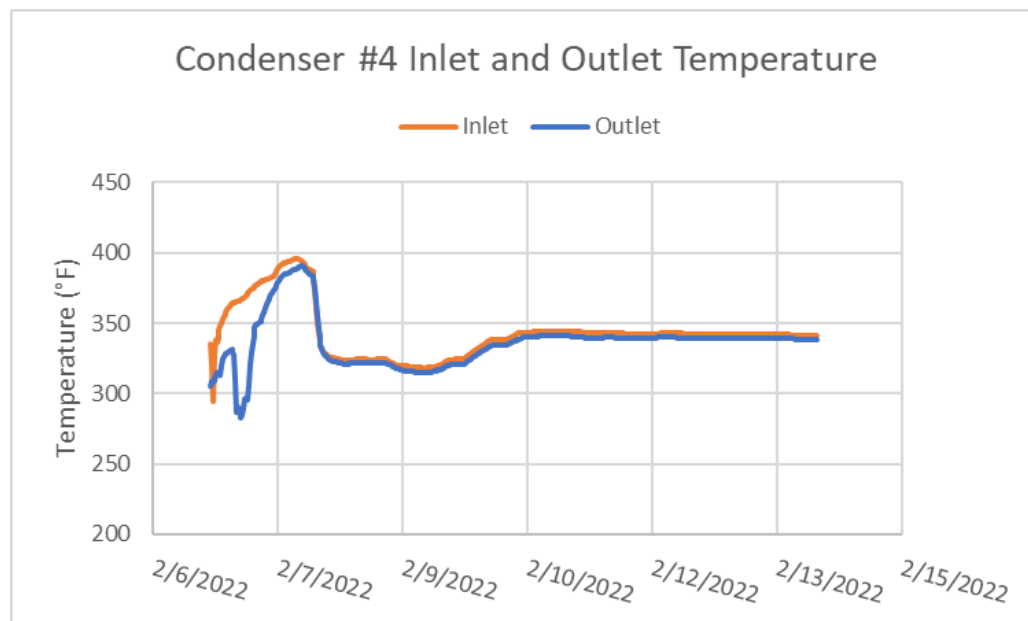
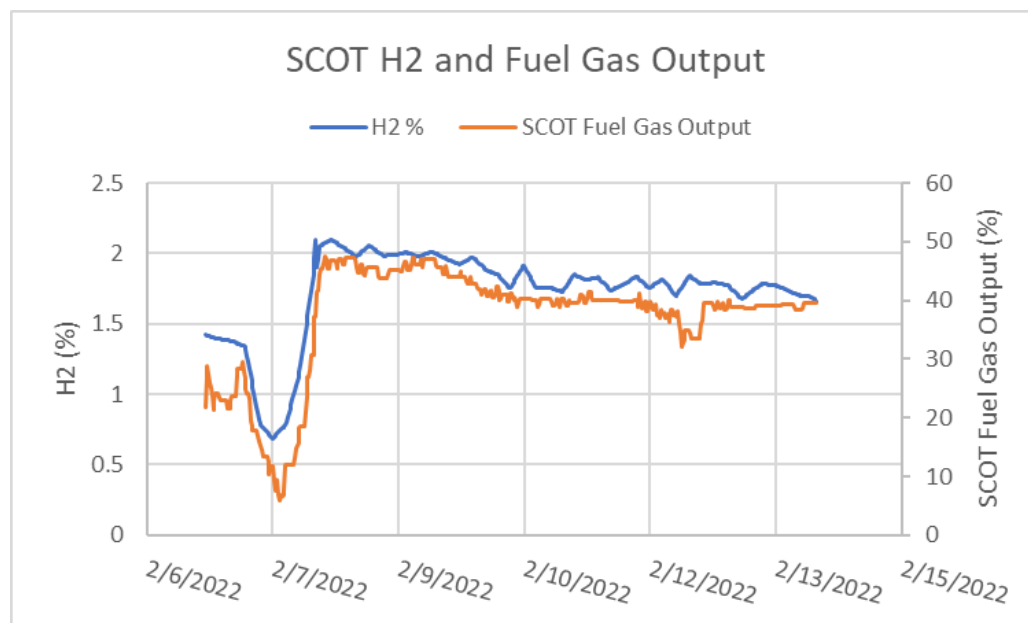
Bypassing #4 Condenser: Initial Operating Conditions

- Executed condenser swap in early February
- Initially kept #3 reheat 390 °F
 - Low SCOT fuel gas output and H₂
- Modified:
 - Reactor inlet 530 -> 550 °F
 - Fuel gas ratio: 80 -> 72%
- Briefly lowered #3 reheat to 320 °F
 - Concern about sub-dewpoint operation
- Final conditions:
 - Reheat at 340 °F
 - SCOT reactor 545 °F

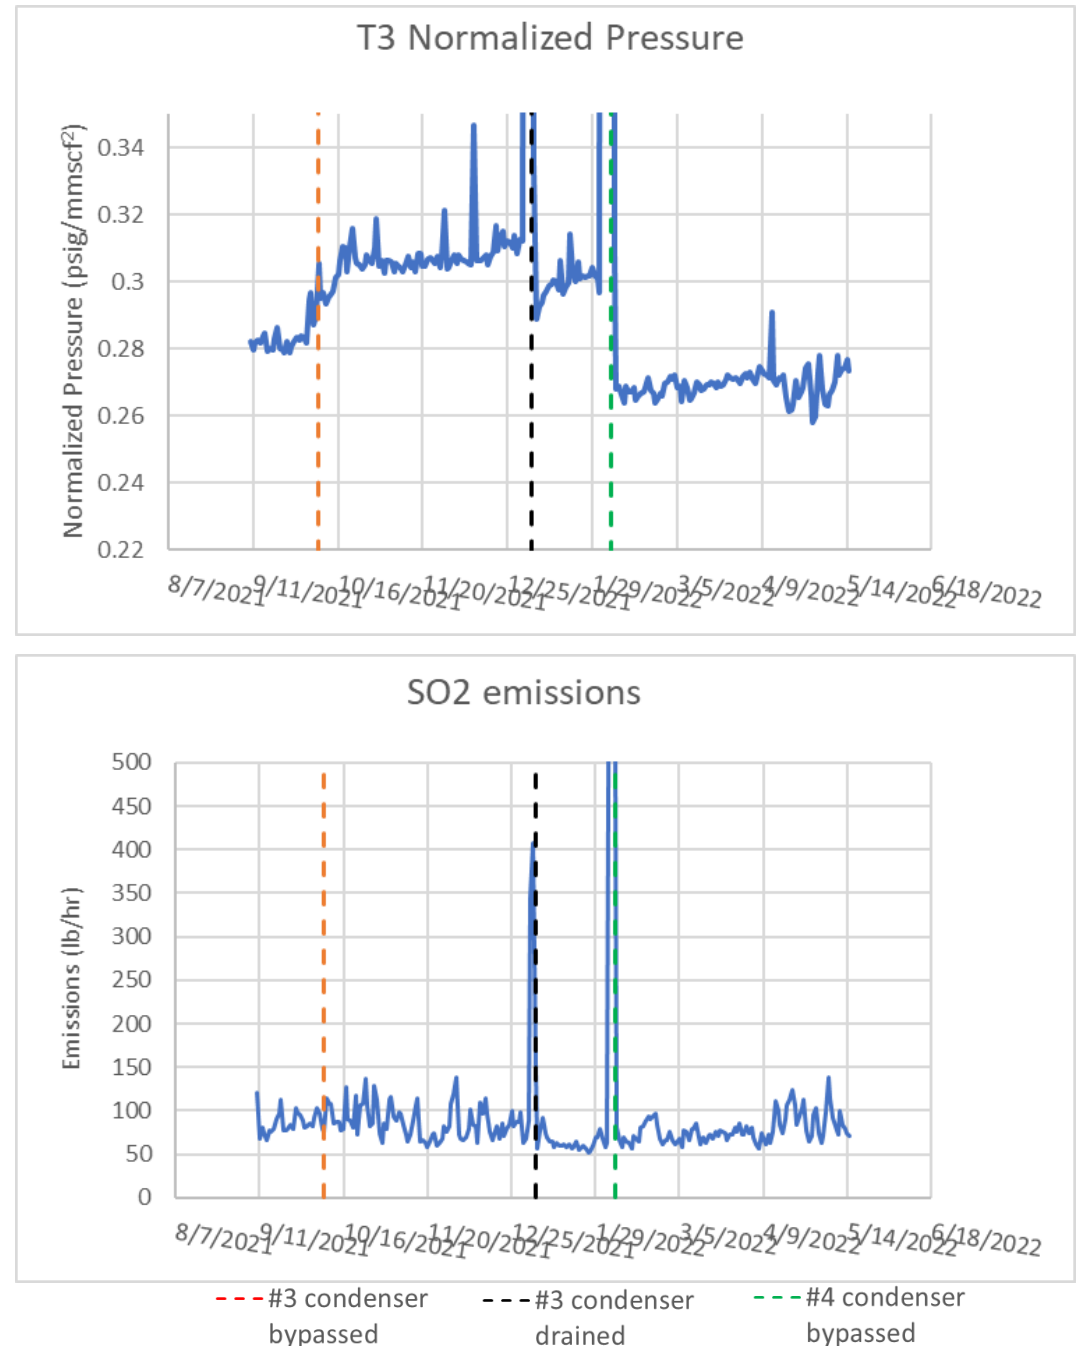
Operating Data: #4 Condenser Bypassed

- Unit lined out well
 - Minimal issues with #3 rundown
 - Small amount of sulfur condensed in #4
 - Normalized pressure improved
 - Higher throughput (>90% nameplate) during other train's turnaround
- No significant impact to SO₂ emissions
