# **Improving Thermal Reactor Safety With Refractory Enhancements**

Rick Johnson – BP

Jeff Proctor – Thorpe Specialty Services Corp

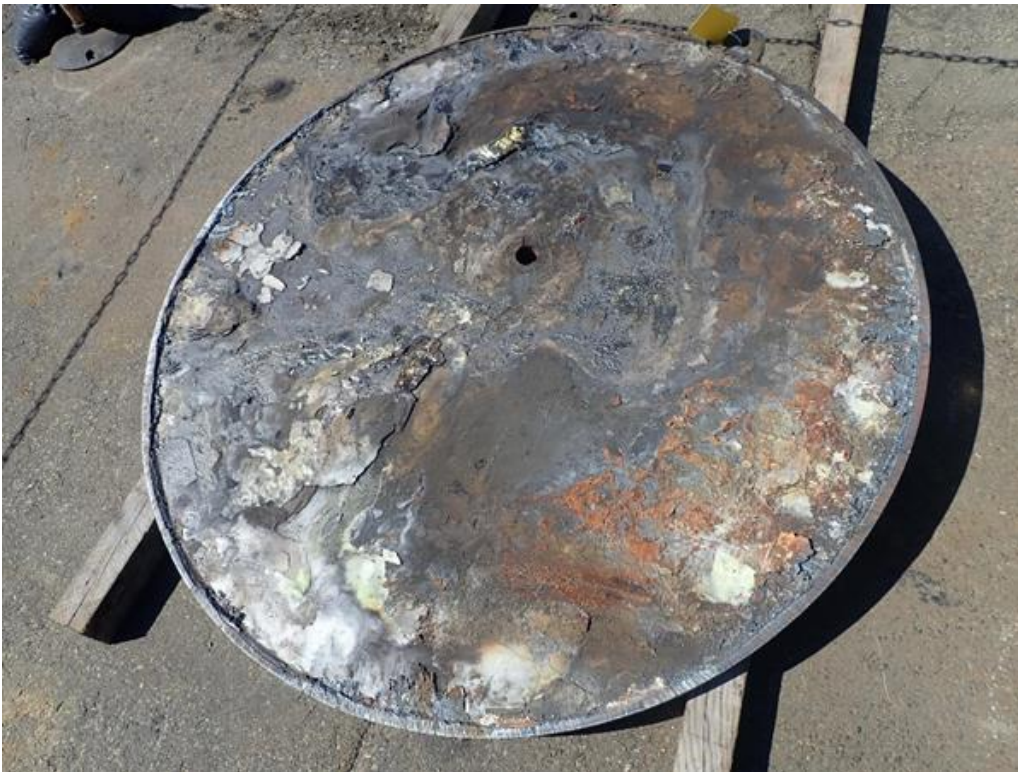
# Endwall

- Numerous documented refractory issues noted in most inspection and maintenance records since initial operation
- Specific issues noted trying to resolve design issues related to flat endwall and peep sight design

- Based on request to provide an enhanced refractory lining for the flat wall area only.
  - Flatwall design – Always a problem for high temperature severe service (i.e. Thermal Reactors).
  - Reliance upon maintenance approach to repairs rather than an engineered approach
    - Not understanding flatwall issues and belief that the monolithic anchors in viewport would hold wall ... or worse, thinking a brick bullseye with no anchors would stabilize the wall
    - Compounding issues with excessive ceramic fiber joints

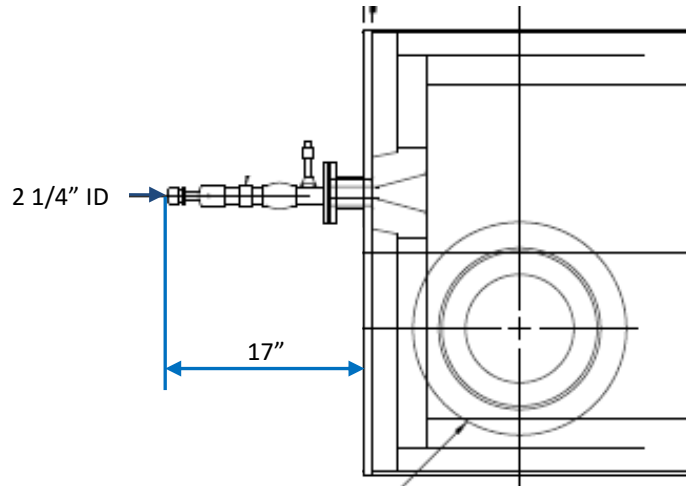
**Before**

- No insulation material, all dense hotface material
- 1" refractory at shell

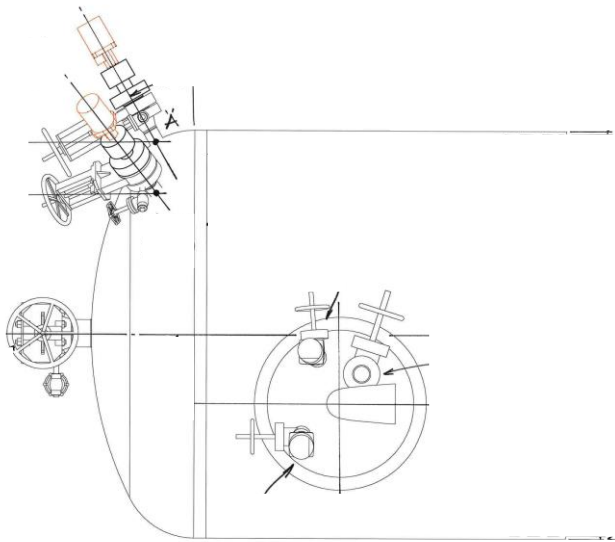
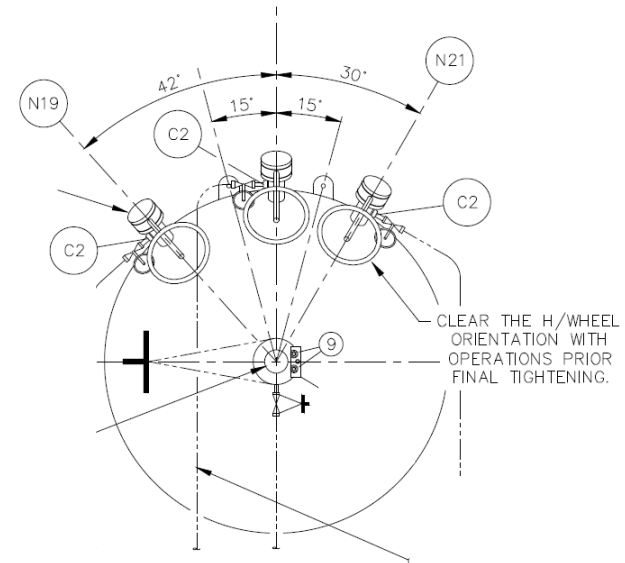
# Flame Scanner Locations

- Initial flame scanner locations being considered
- Decided to put all new nozzles onto the new elliptical head to minimize field construction time during outage.
- Many discussions held to find optimal position for flame scanners while minimizing the impact to the refractory lining
