## Startup Foaming Issues on a New MDEA Tail Gas Unit

2021 Brimstone Sulfur Symposium

*S. Copper, K. Thomas, B. Viceria, S.  
Goff, J. Contreras, L. Nyadong, J.  
Stavros – Phillips 66*

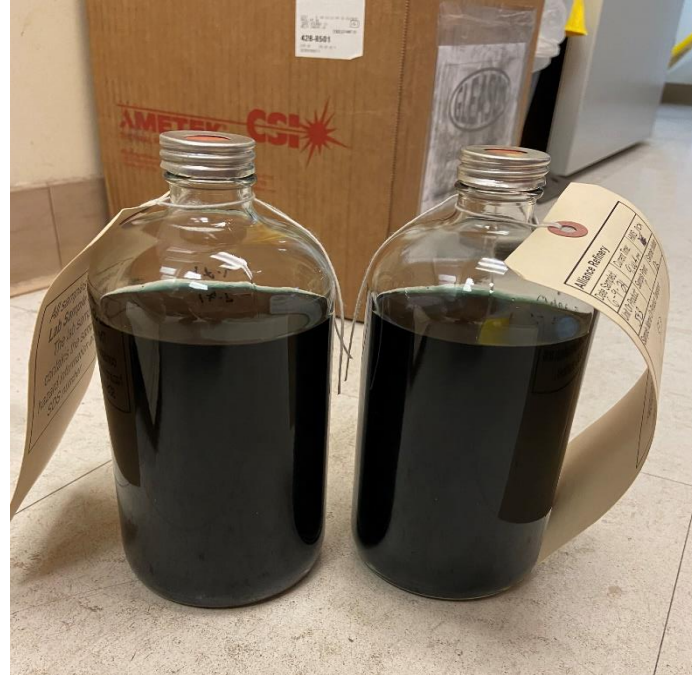
The Alliance team was interested on identifying the presence of polysulfides that might be formed from the reaction of  $\text{SO}_2$  with amines. Polysulfides include both organic polysulfides ( $\text{RS}_n\text{R}$ ) and inorganic polysulfides ( $\text{H}_2\text{S}_n$ ).

An organic sulfide or thiane
